NJ FACE INVESTIGATION REPORT

FACE 98-NJ-038-01

Laborer Killed When Forklift Truck He was Operating Overturned

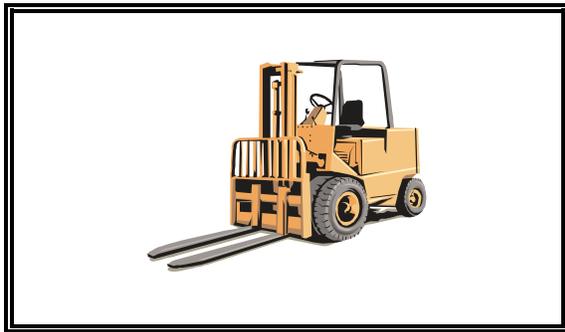
Example of a forklift truck

The company owned two forklift trucks: the propane-powered truck involved in the fatality and an electric-powered one. The two forklifts had different operational features. The propane-powered truck was lighter in weight than the electric forklift, had a more rapid take-off speed, and the operator had to use the brake to slow the machine. A forklift operator said that the faster speed of the propane-powered truck would have
