Field Assessment Form

New Jersey Community Development-Disaster Recovery Block Grant (CDBG-DR)
Hurricane Sandy Disaster Recovery Program

Applicant ID: NCR39567	
PAMS Pin: Multiple	DCA Grant Number: B-13-DS-34-0001
Applicant Name: City of Perth Amboy	Inspection Date: 10/21/2014
Damage Address: Waterfront Park and Marina Area	Inspector: Malik Rasool
Program Type: NCR	Project Description: New Construction Outside Allowable Footprint
Location Verified By: Existing recreational features	Parcel Status: Recreational features largely exist

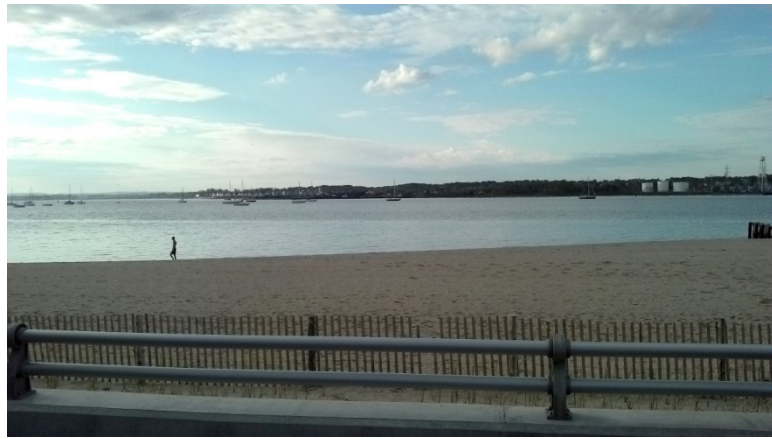
NCR39567Photo05

Description: Looking out toward the water. New wall / railing and sand dunes fence can be seen in photo.

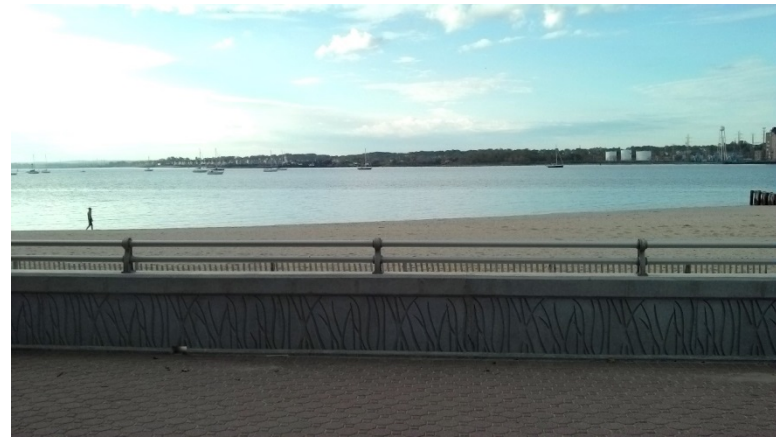
NCR39567Photo06

Description: Looking out toward the water. New wall / railing, sidewalk, and sand dunes fence can be seen in photo.

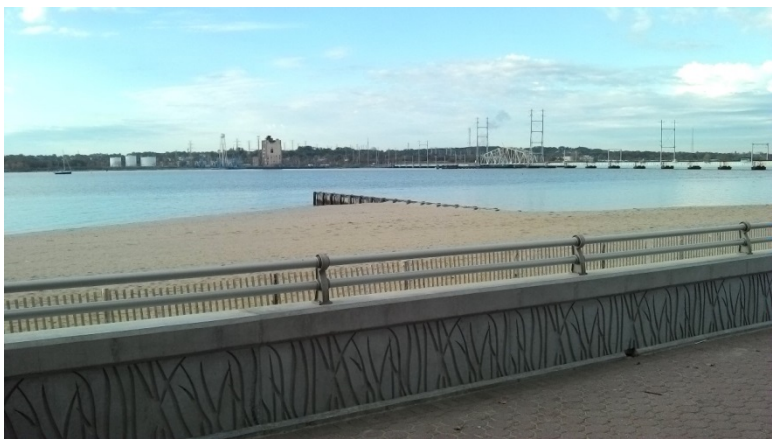
NCR39567Photo07

Description: Looking out toward the water. New wall / railing, sidewalk, and sand dunes fence can be seen in photo.

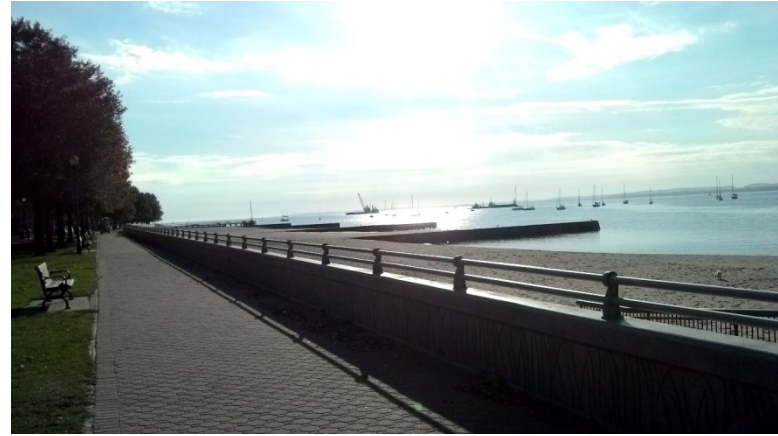
NCR39567Photo10

Description: New wall / railing and sidewalk can be seen in photo.

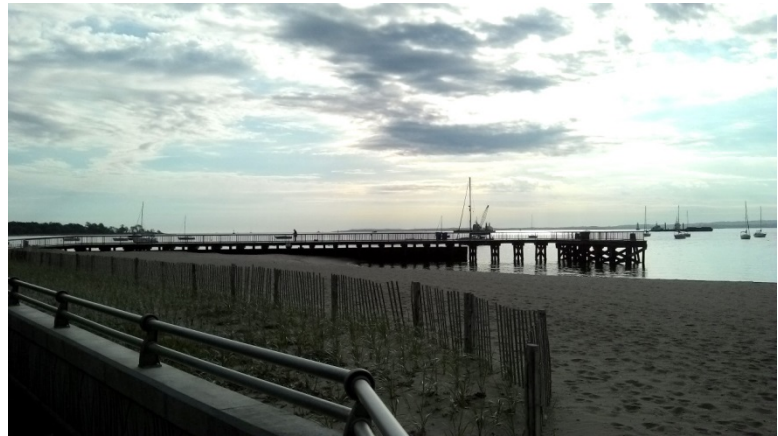
NCR39567Photo16

Description: Fishing pier and sand dune grass can be seen in photo

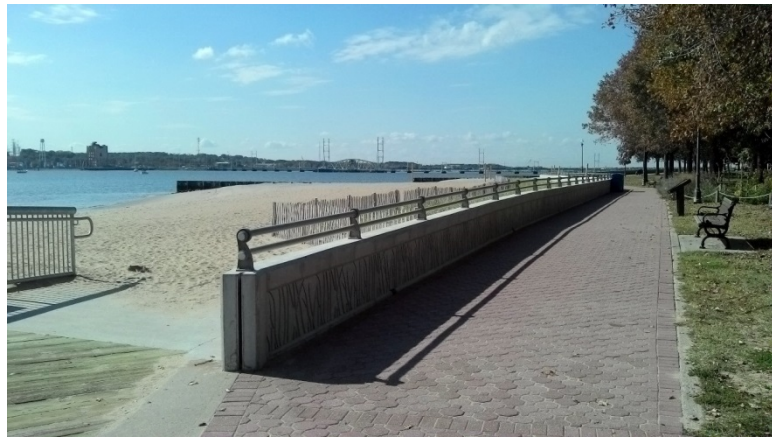
NCR39567Photo21

Description: Looking toward the beach. New wall / railing and sidewalk can be seen in the photo.

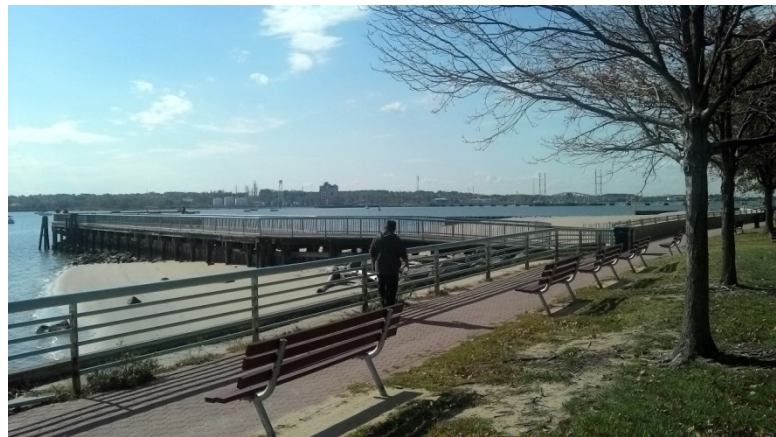
NCR39567Photo24

Description: Fishing pier, location of existing railing and new wall can be seen

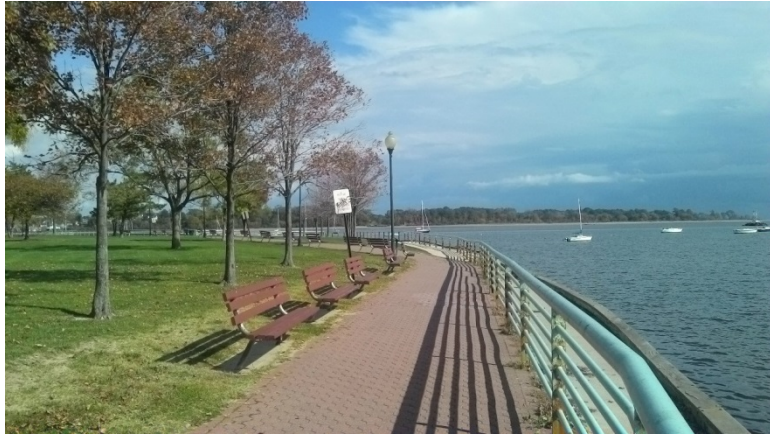
Description: Existing railing and walkway

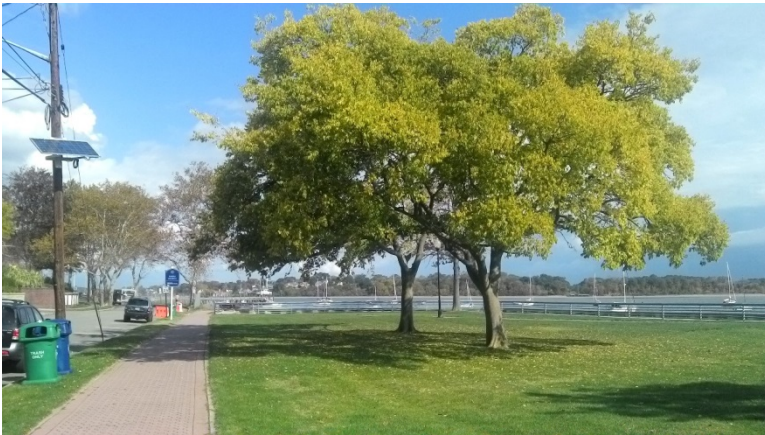
Description: Existing walkway and park area

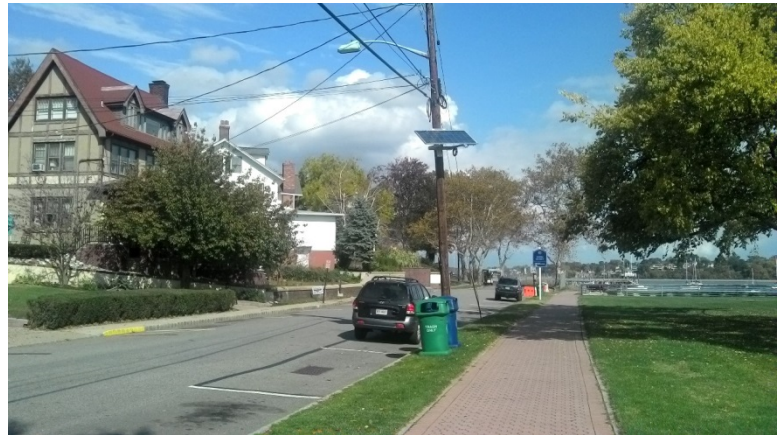
Description: Existing walkway and curbline

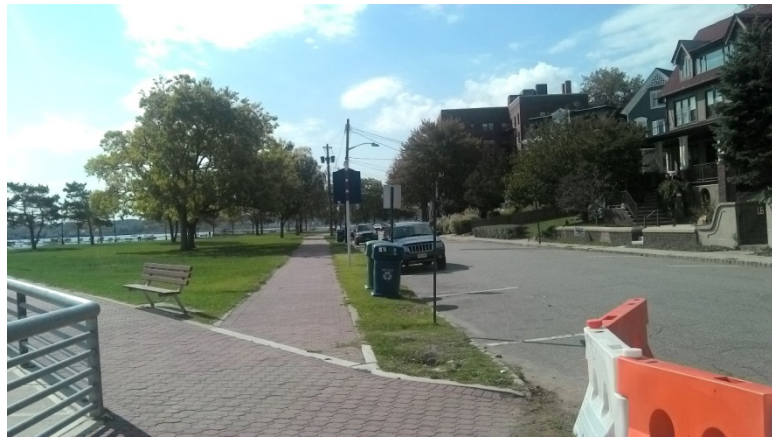
NCR39567Photo29

Description: Existing walkway and curb are shown. Construction barriers can be seen in the photo.

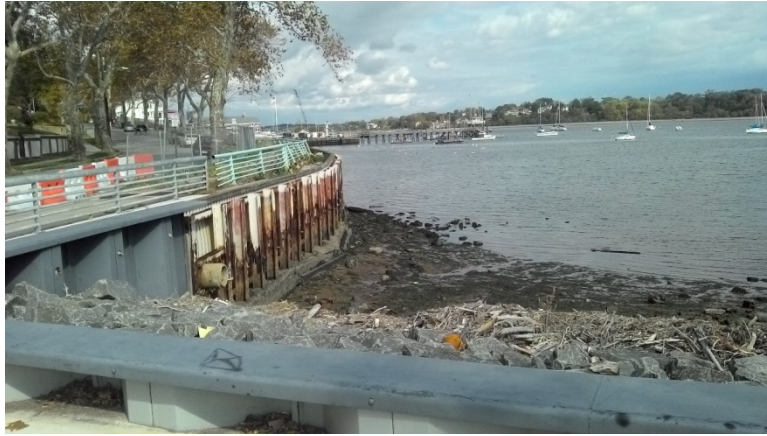
Description: Woody debris in an area near Lewis Street

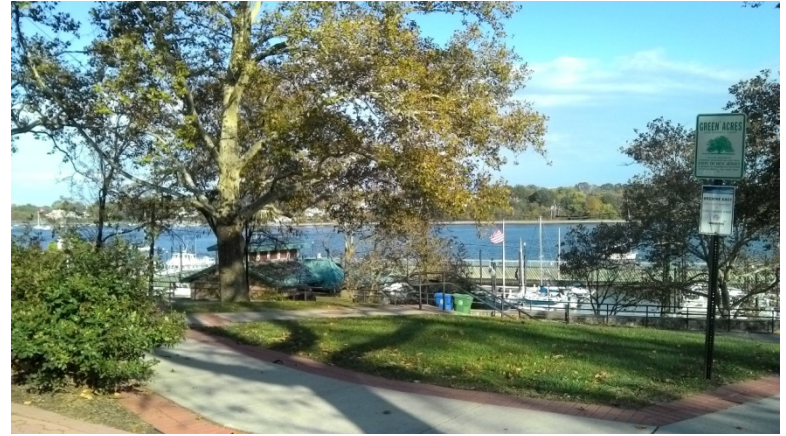
NCR39567Photo25

Description: Park details

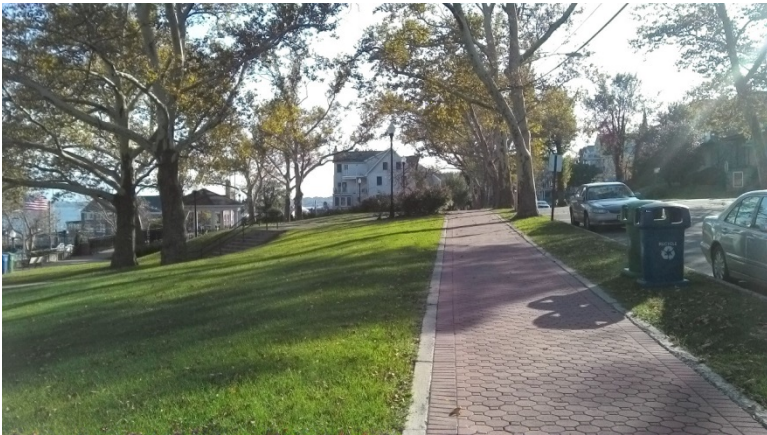
NCR39567Photo26

Description: Photo showing the general topography of the park

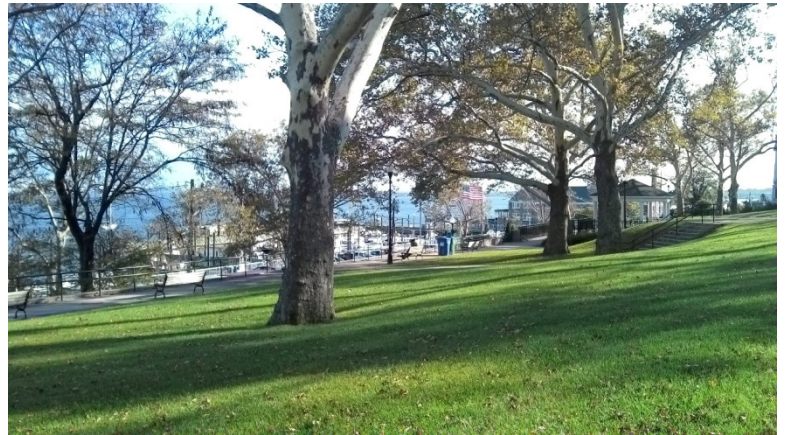
NCR39567Photo27

Description: Photo showing the general topography of the park

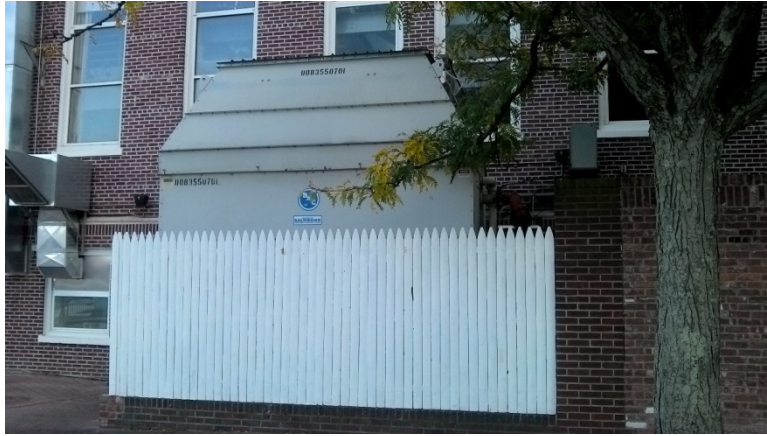
NCR39567Photo28

Description: This is equipment inside the Armory restaurant. Likely to be garbage-related equipment.

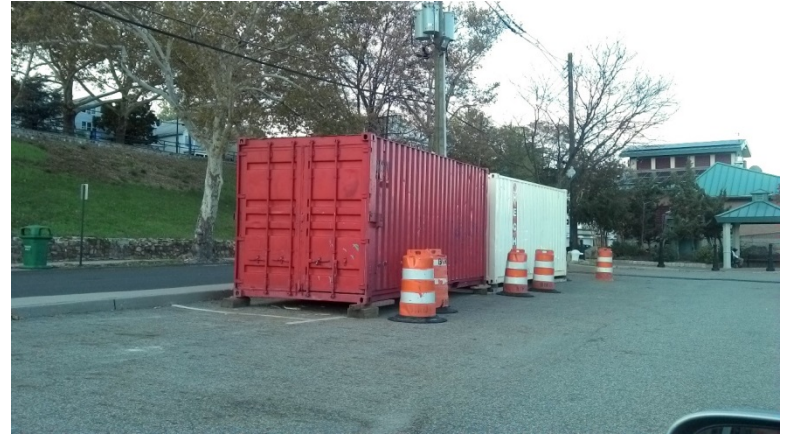
NCR39567Photo29

Description: Construction trailer on site in the parking area

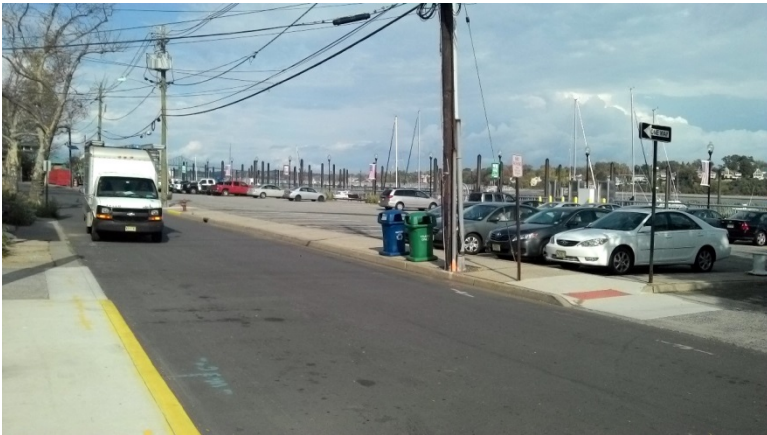
NCR39567Photo30

Description: Front Street near the Armory

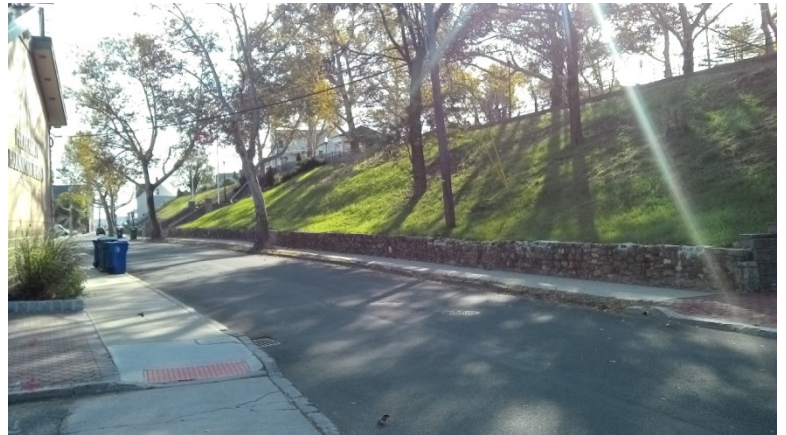
NCR39567Photo31

Description: Street details – Bayview Park is located to the right of the photo.
