Bridge Site Visit Report

ARUP

Hackensack River, 4.17

Date	July 14, 2020
Surveyor	Heros Gnesotto

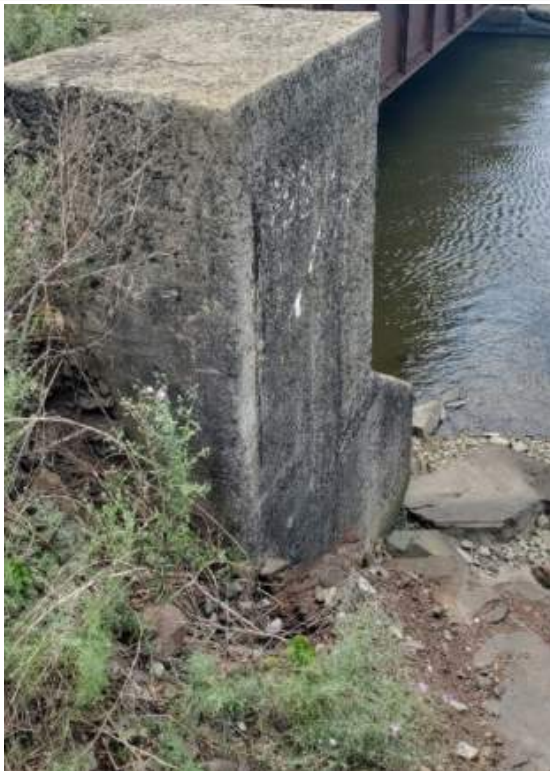
(10) Substructure in east approach with significant spalling at waterline

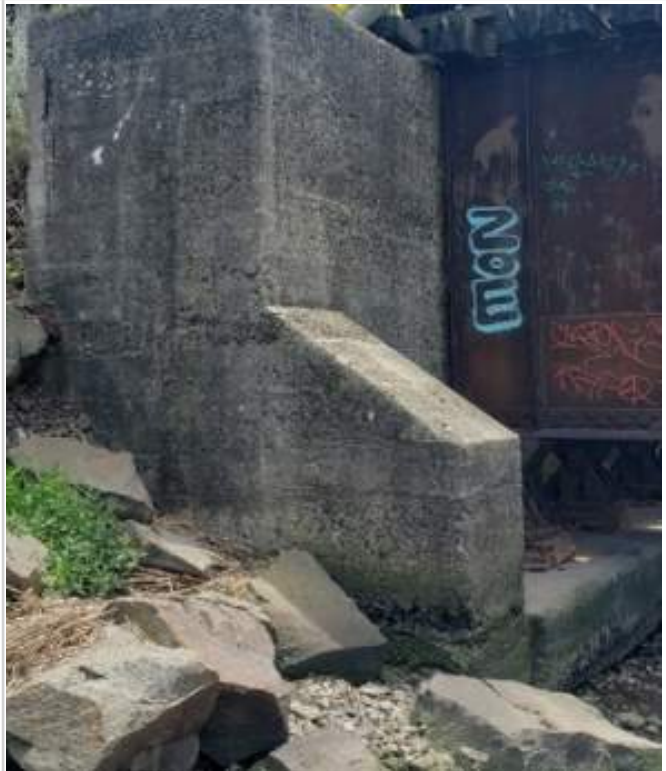
(11) View of east abutment with concrete in generally good condition

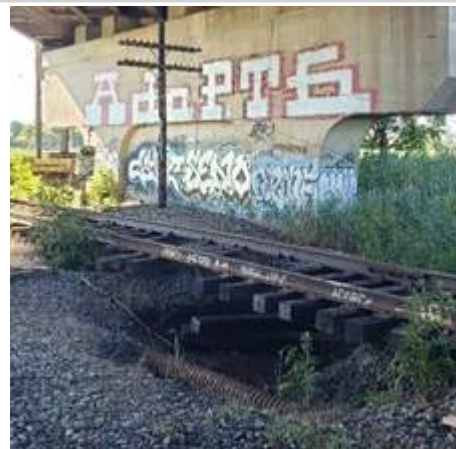
(4) The ground approximately 300 feet west of the bridge is washed out

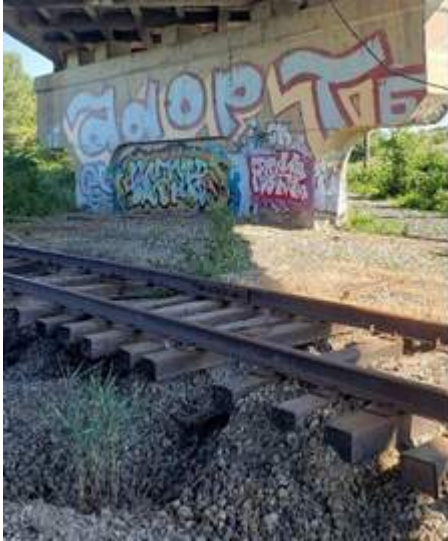
(5) The ground approximately 300 feet west of the bridge is washed out

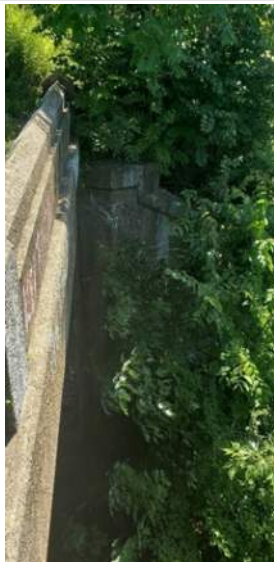
(3) Looking at western abutment from top of bridge

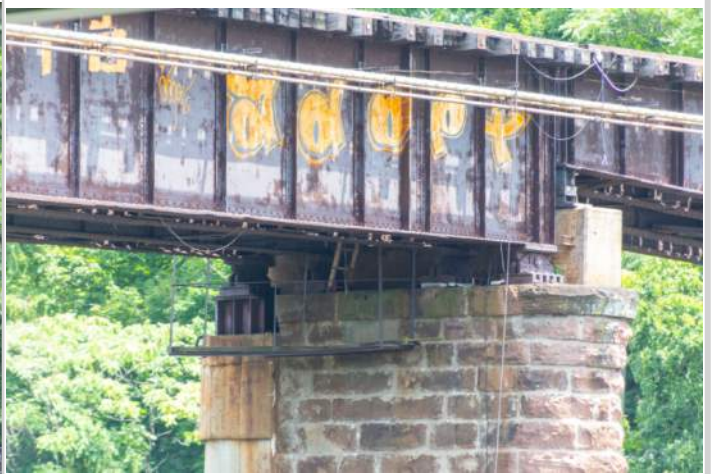
(12) Evidence of past rehabilitation measures used on the bearings at one of the piers

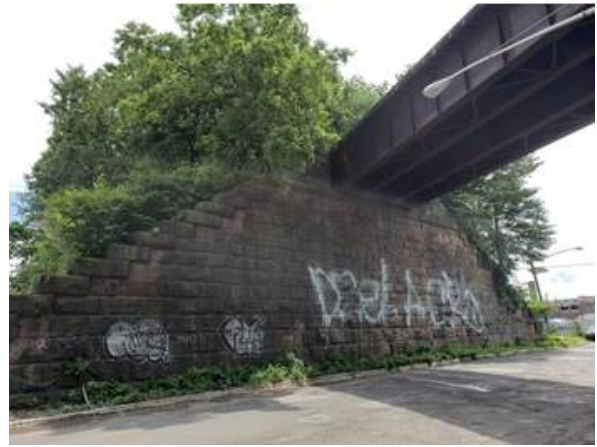
Bearings/Bearing Seat Remarks	Unable to see
Stem Wall/Wingwall Type	Concrete/Masonry
Stem Wall/Wingwalls Condition	Good
Stem Wall/Wingwall Remarks	Stone finish, most likely structural concrete walls
Foundation Type	Masonry
Foundation Condition	
Foundation Remarks	
Scour/Erosion Remarks

(2) Overview of eastern abutment

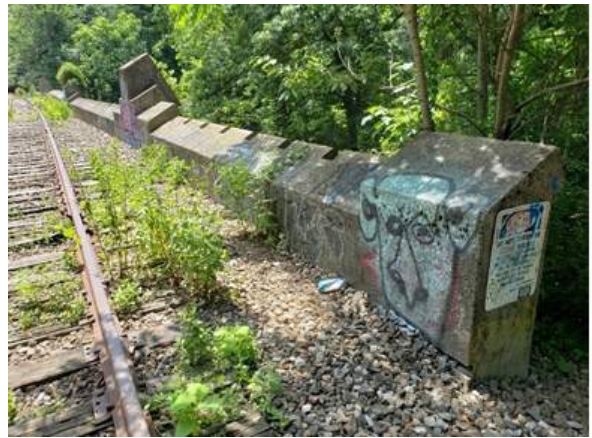
(2) Graffiti on parapet

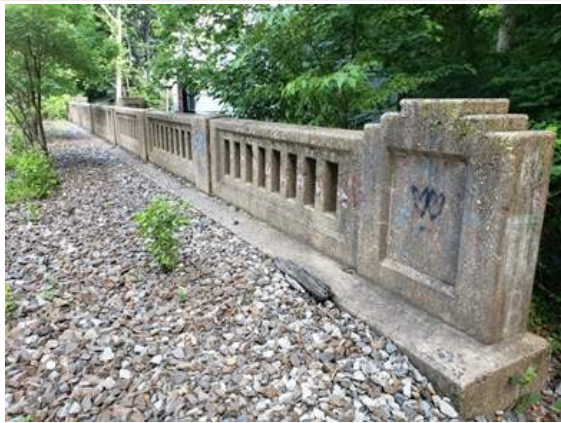
(3) Graffiti on parapet

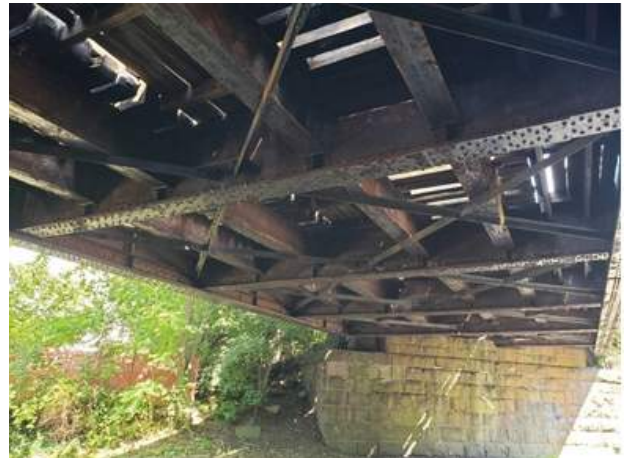
(2) Overview of western abutment

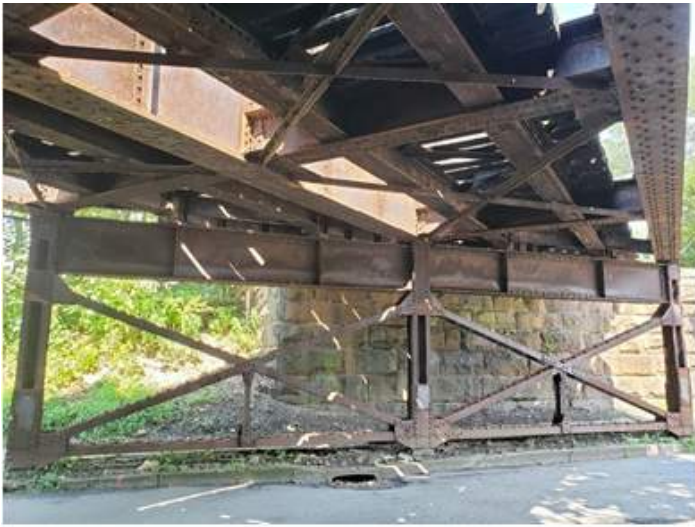
Bearings/Bearing Seat Condition	Unknown
Bearings/Bearing Seat Remarks	
Stem Wall/Wingwall Type	Concrete/Masonry
Stem Wall/Wingwalls Condition	Good
Stem Wall/Wingwall Remarks	Stone clad, most likely structural concrete
Foundation Type	Masonry
Foundation Condition	
Foundation Remarks	
Scour/Erosion Remarks	None

(3) View of western abutment and pier

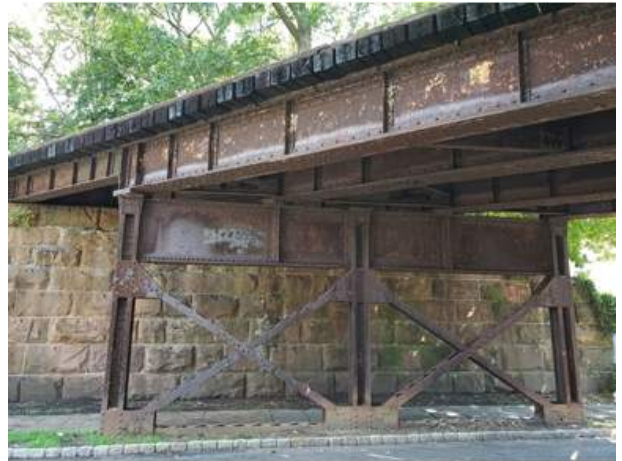
(4) Northern abutment and pier

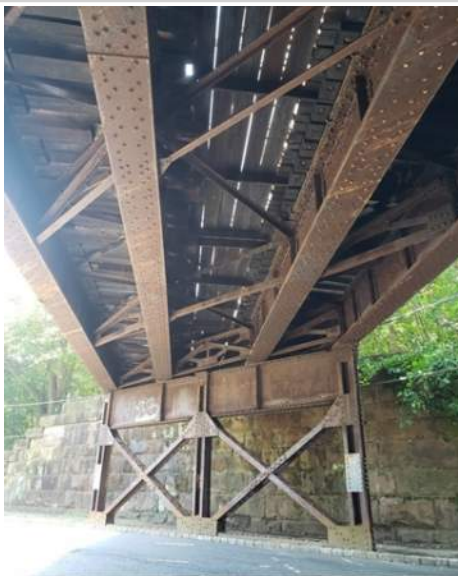
(5) Southern abutment and pier

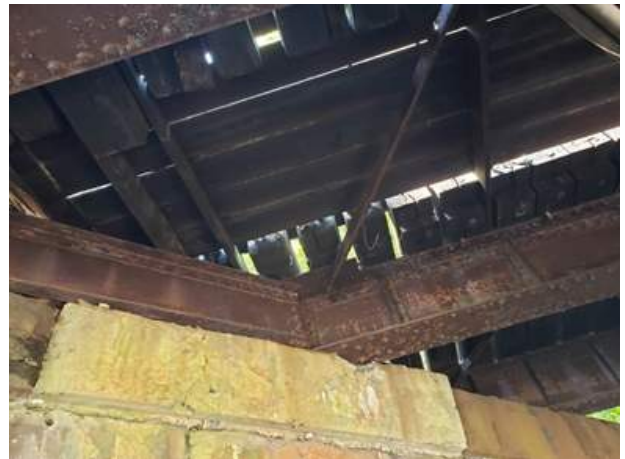
(6) Past rehabilitation to abutment
