# **SCOPE OF WORK**

## **Restoration of Windows and Doors**

Boxwood Hall Historic Site Elizabeth, Union County, NJ

# WINDOW CONDITIONS AND STRUCTURAL ASSESSMENT AT BOXWOOD HALL RESIDENCE STATE HISTORICAL SITE & MUSEUM 1073 E. JERSEY ST., ELIZABETH, NJ 07201

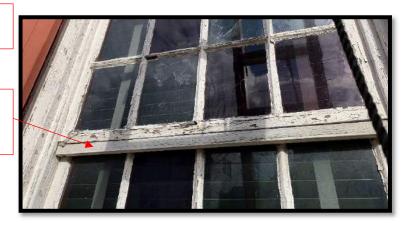
The window currently has a reinforcing block of wood that is supporting the meeting rail, as well as sealant placed, as it has already began to deteriorate. The meeting rail will need replacement under "Repair Class 3" and a new sill block will need to be provided. Other damage may be repaired through means detailed in "repair class 2". All general maintenance procedures should be conducted here as well, such as repainting the interior and exterior faces of the window.

Damaged Meeting Rail

Reinforcing Block at Meeting Rail

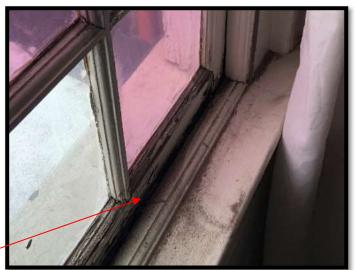
Beginning of Deterioration

Gap at Window / Sill

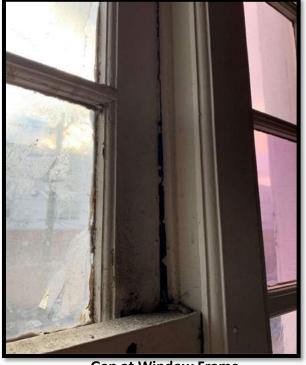
**Gap at Window Frame**

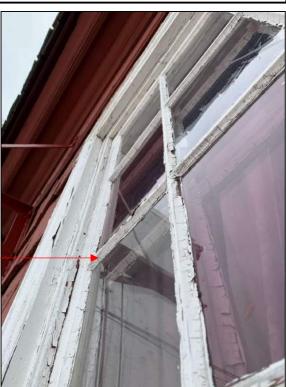
Overview of Escape Platform and Window

Overview of Minor Damage to Exterior Face

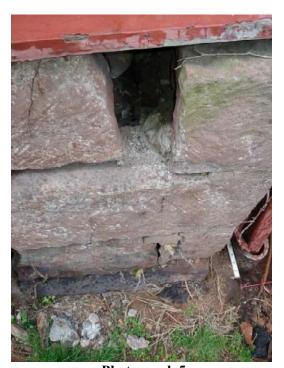
Photograph 5

Large gaps have formed between the brownstone and the exterior brownstone have separated from the fieldstone backup (Photograph 5).

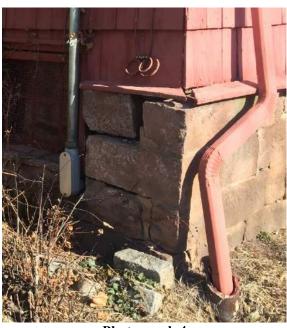
Photograph 4

The exterior brownstone in the southwest building corner have displaced outward in both the south and west direction. The stones appear to have settled in addition to the outward displacement (Photograph 4).
