SCOPE OF WORK

Trenton Office Complex Roof Restoration

MVC Central Headquarters Building
225 East State Street
Trenton, Mercer, NJ

Project No. A1382-00

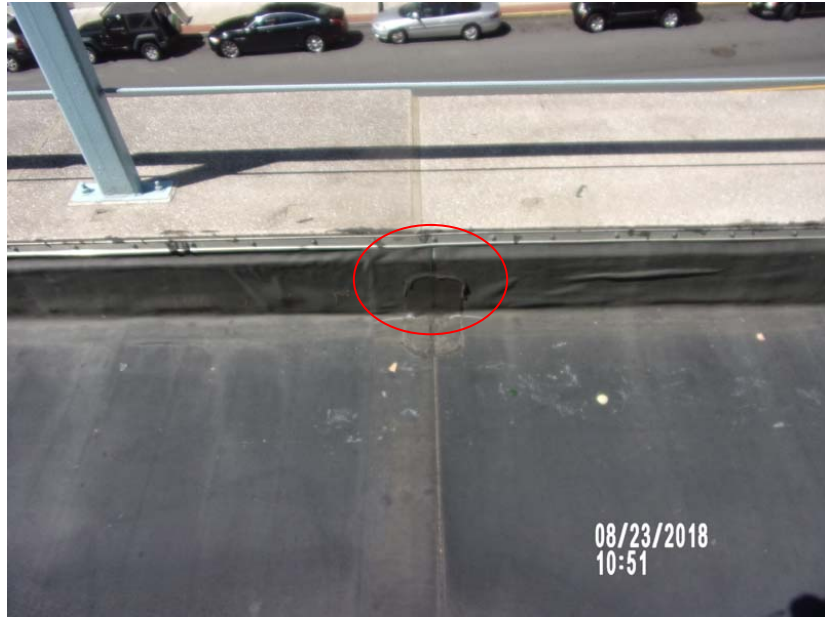
2. Roof Area A: Delaminating lap seam support patch on parapet.

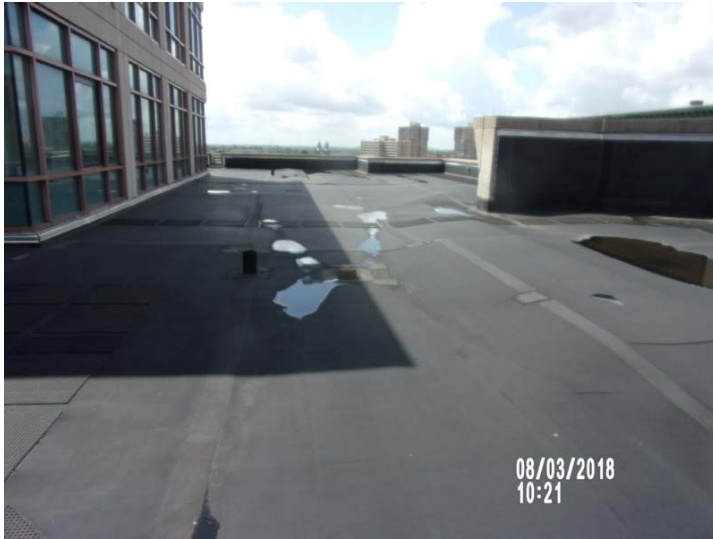
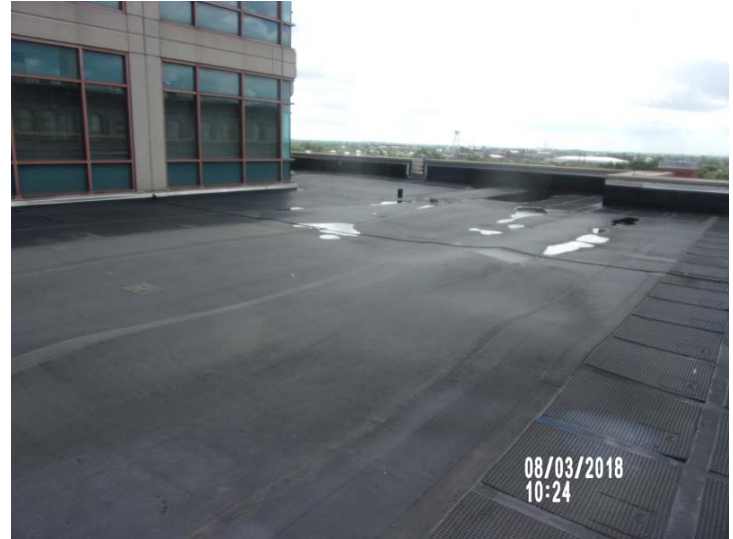
3. Roof Area B: Overall views showing the raised EPDM from delaminated insulation from the concrete deck that has buckled. This did not affect the waterproof integrity of the roof. Sample cuts were performed as discussed later within this report under the Roof Cut Analysis Section.

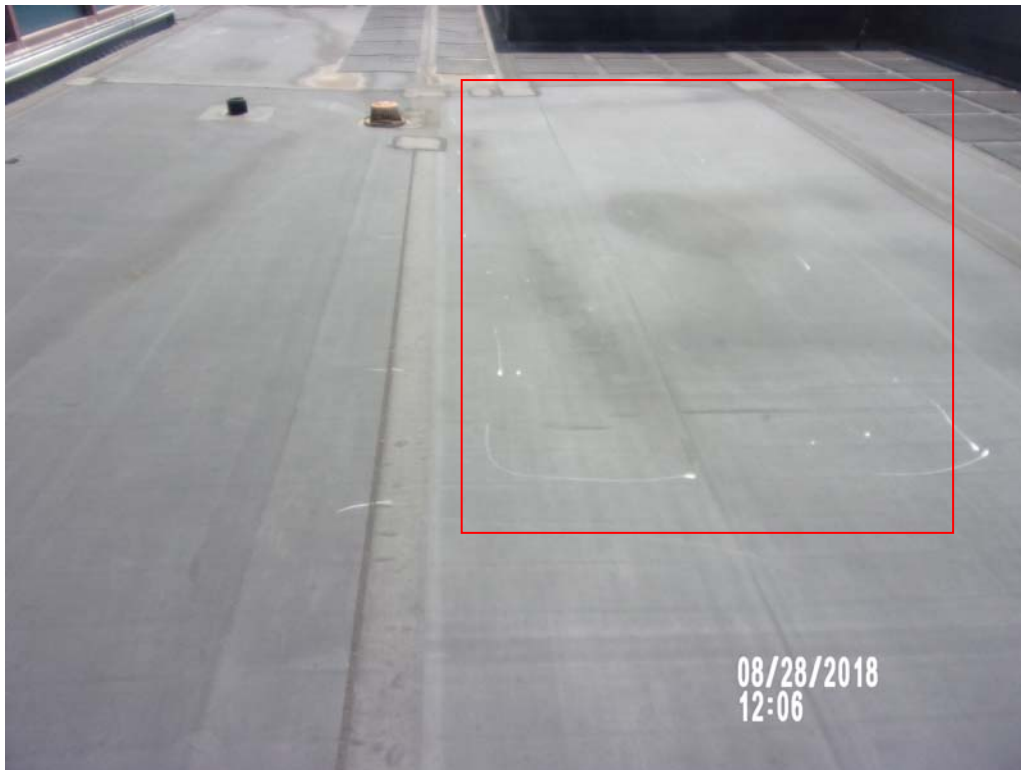
1. Roof Area C: View showing raised EPDM membrane from delaminated insulation from the concrete deck that has buckled.

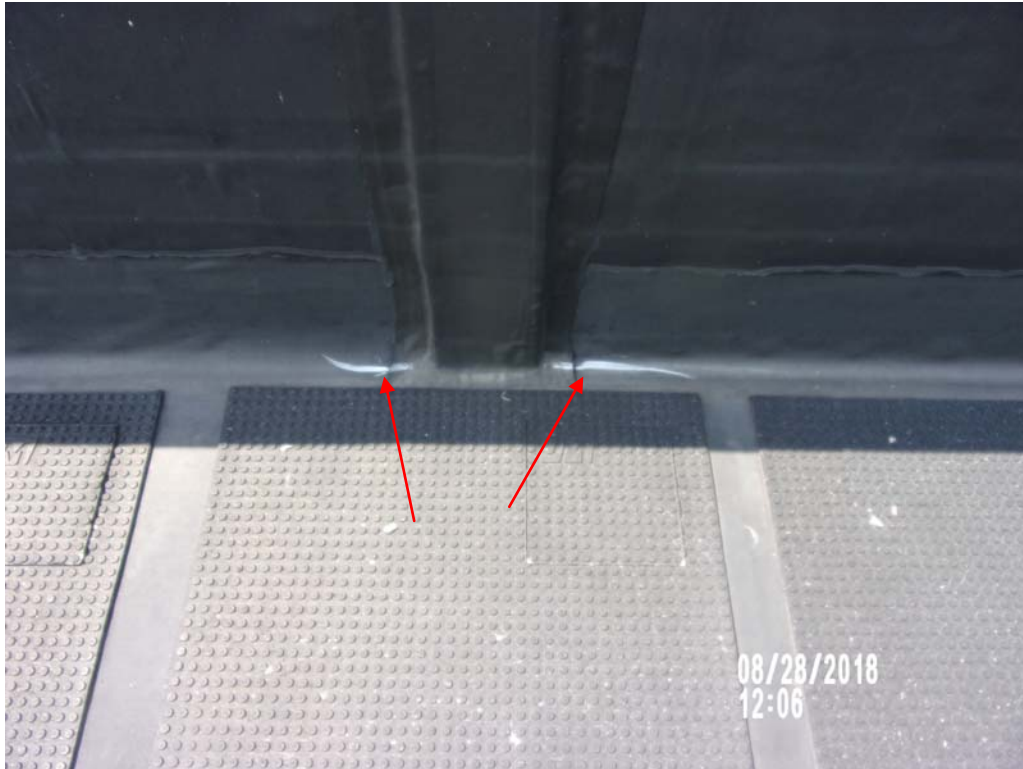
4. Roof Area C: Two open lap seams in the EPDM membrane flashing on the parapet wall.

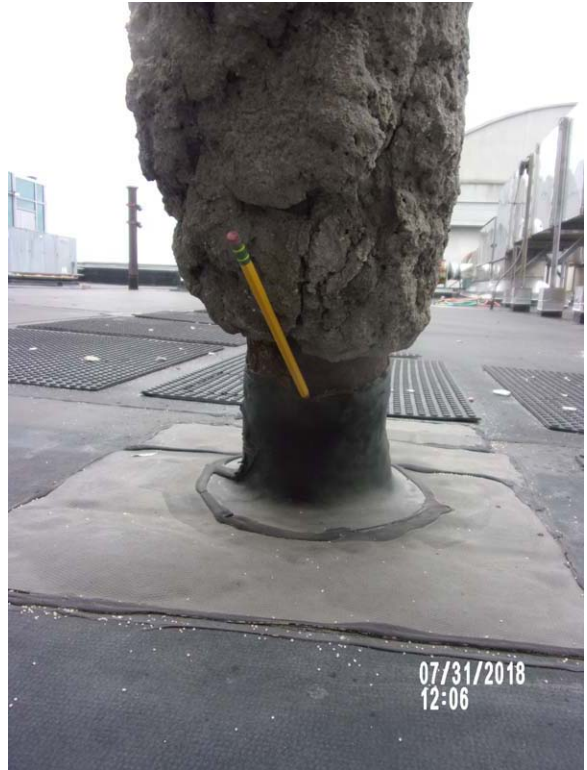
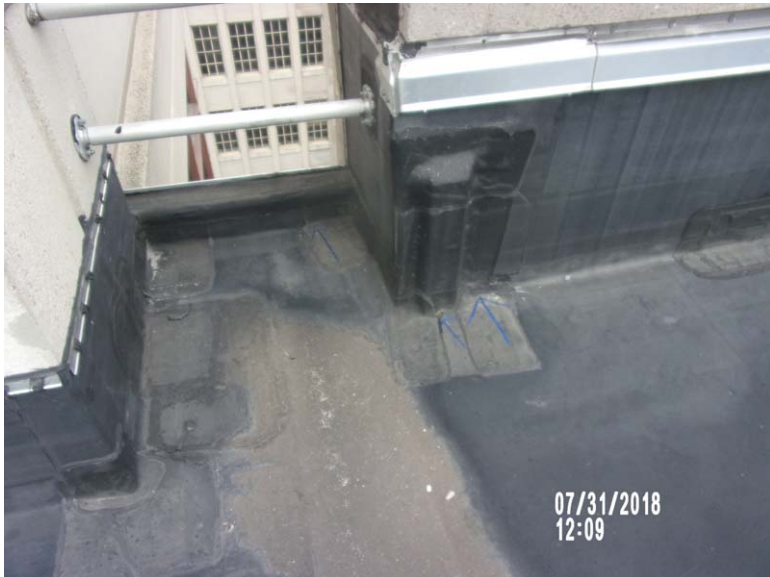
6. Roof Area D: Delaminating vertical lap seams in the parapet wall membrane flashing.

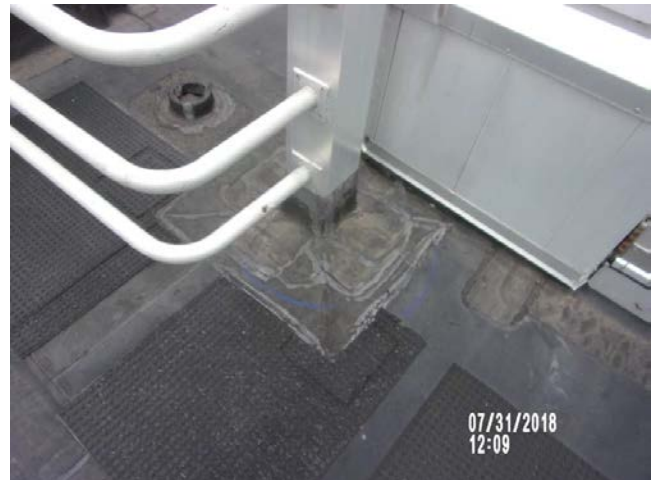
7. Roof Area D: Safety rail support pipe EPDM membrane flashing wrap delaminating.

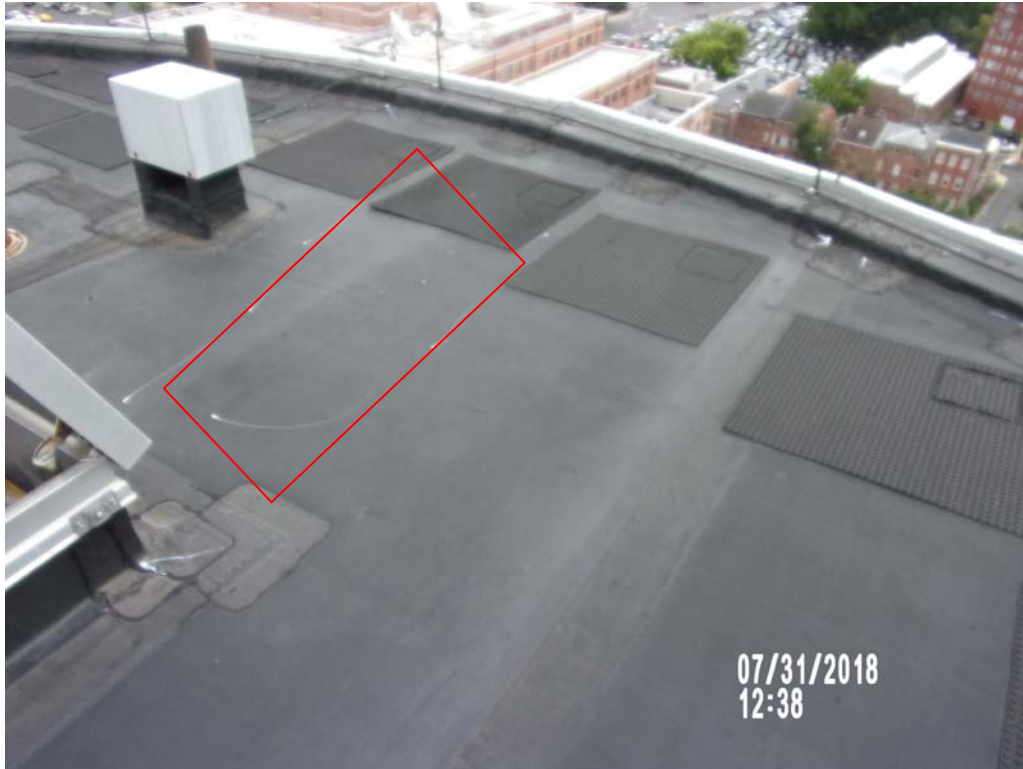
1. Roof Area D2: Area approximately 18 square feet where the insulation delaminated from the concrete deck.

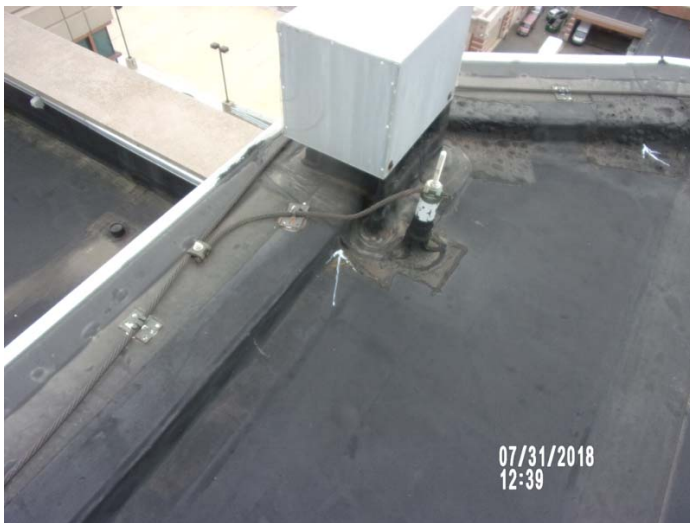
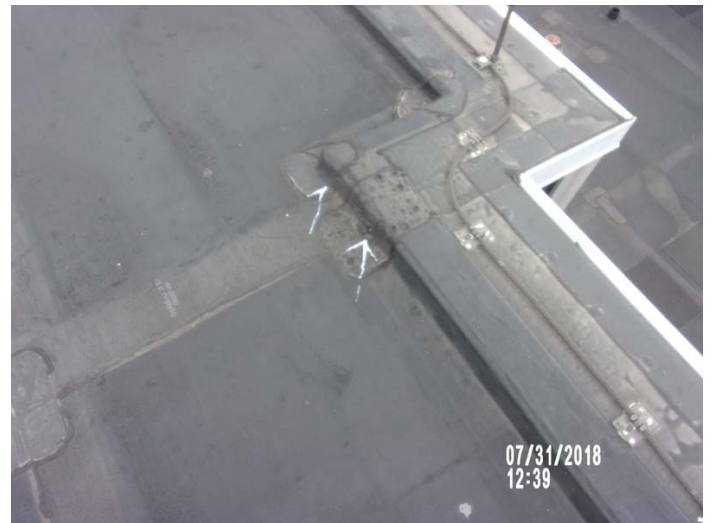
2. Roof Area D2: Typical open lap seams at an elevation change.

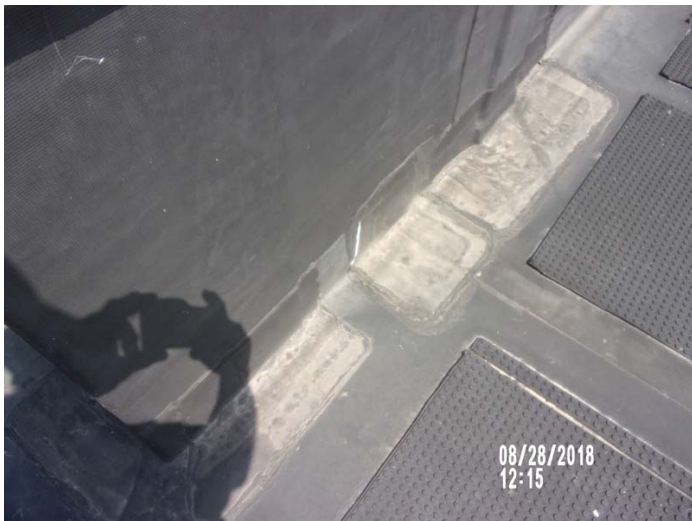
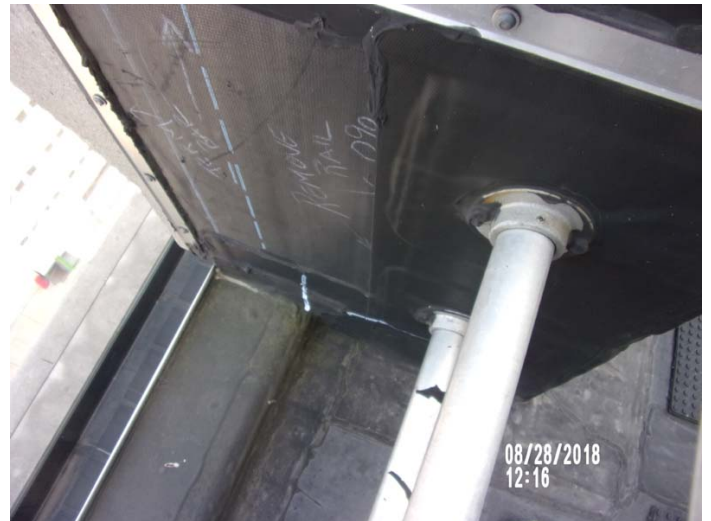
2. Typical delaminating support patches at the base of the parapet wall.

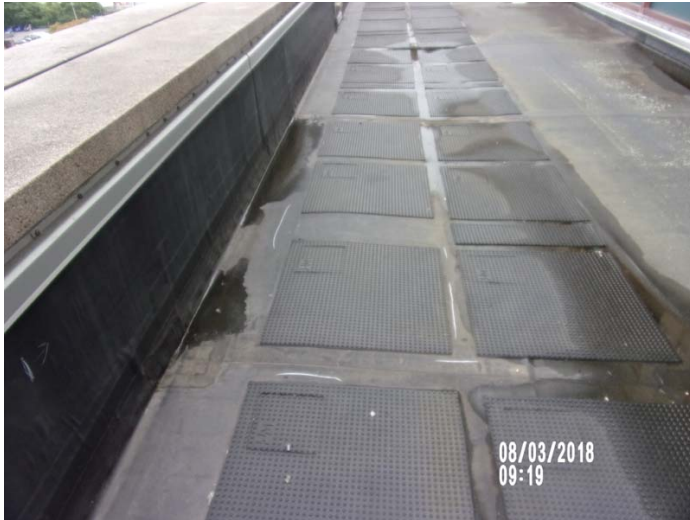
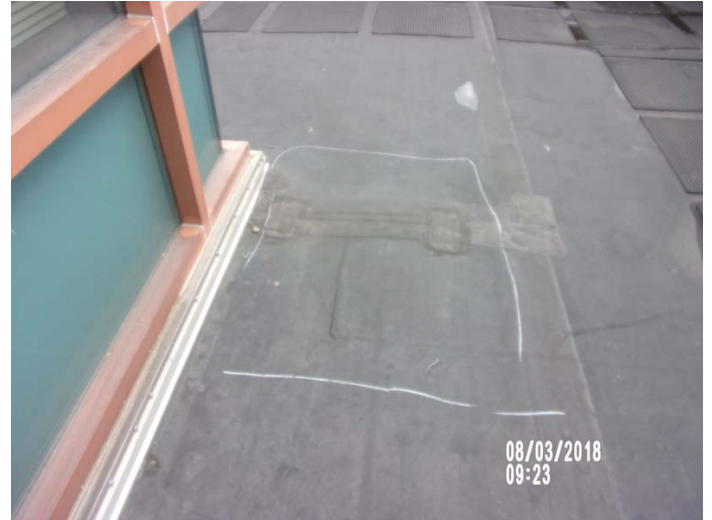
2B. Roof Area L: The above two (2) photographs again show additional smaller sections of delaminated insulation raising the EPDM membrane.

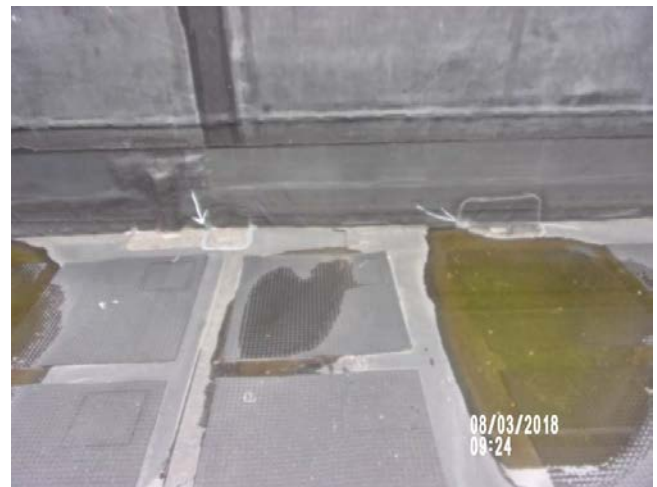
4. Roof Area L: Hole in the field EPDM membrane.

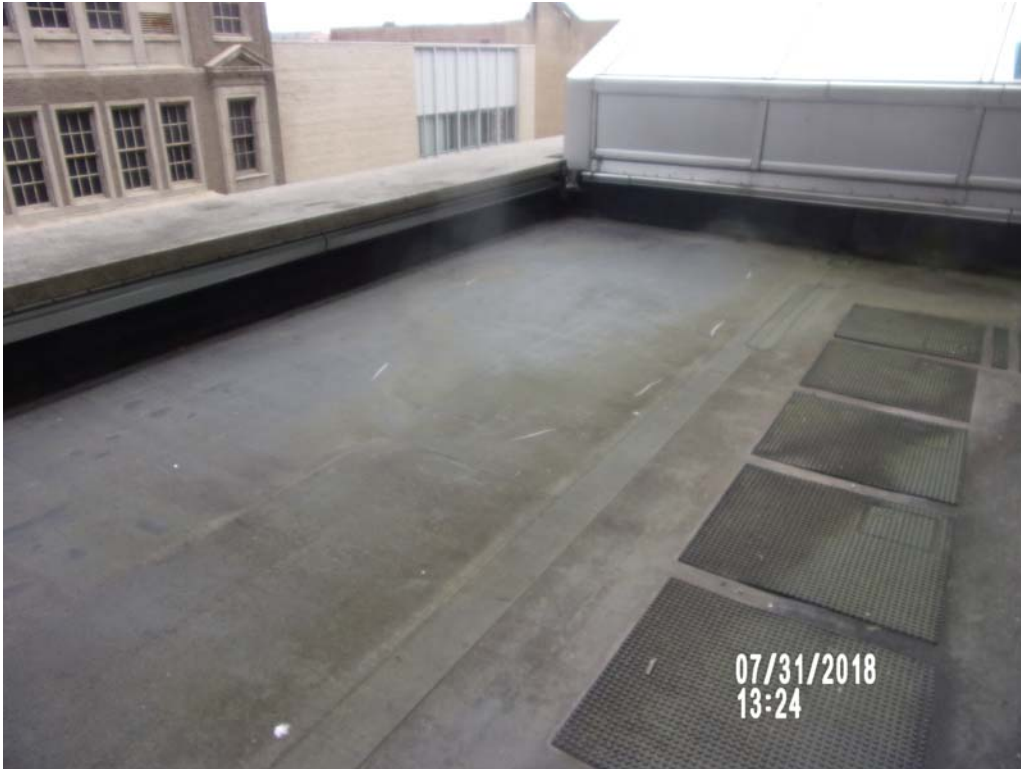
1. Roof Area M: A section of the roof where the insulation delaminated from the concrete deck which buckled raising the EPDM roof membrane.

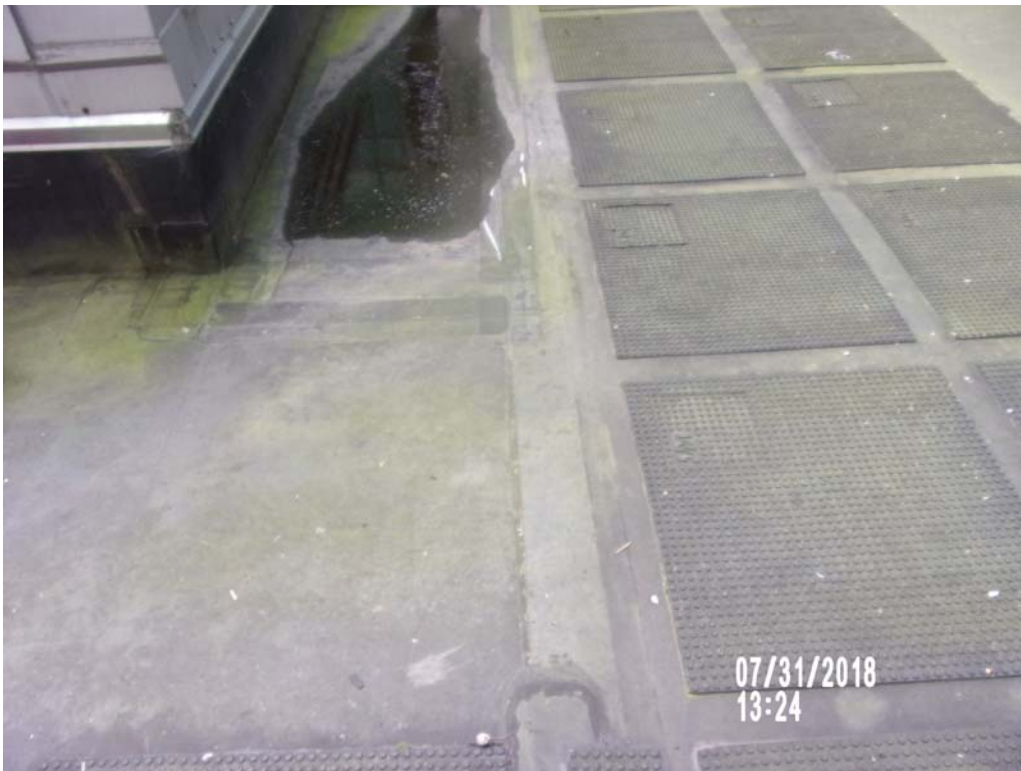
2. Roof Area M: A field lap seam that has been stripped. The stripping is beginning to delaminate.

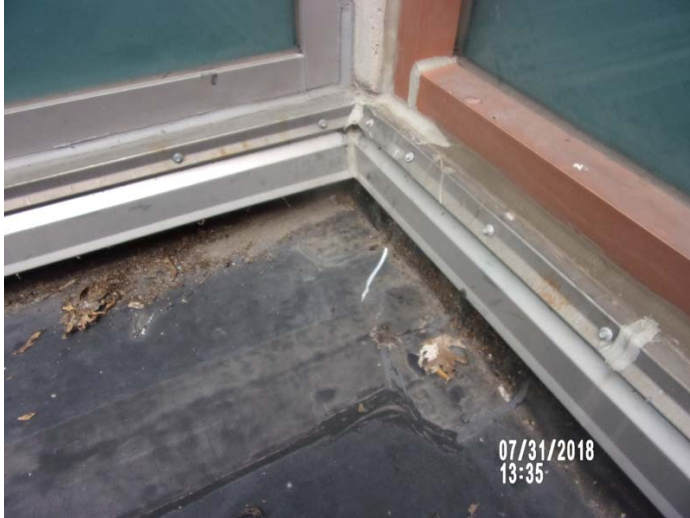
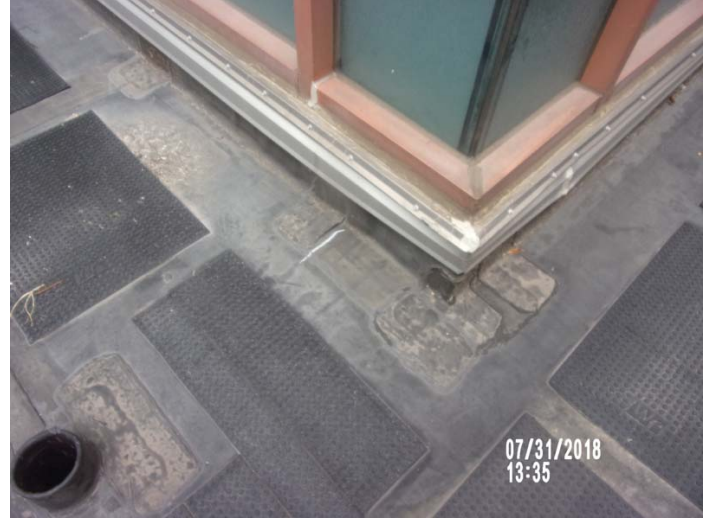
1. Roof Area N: Typical EPDM membrane delamination.

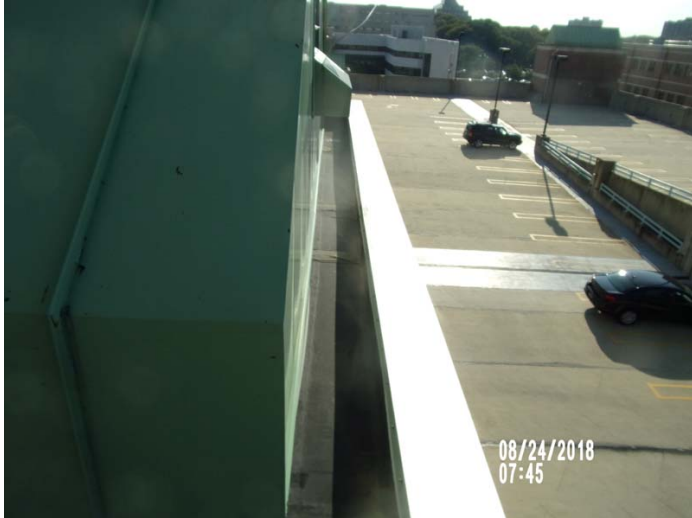
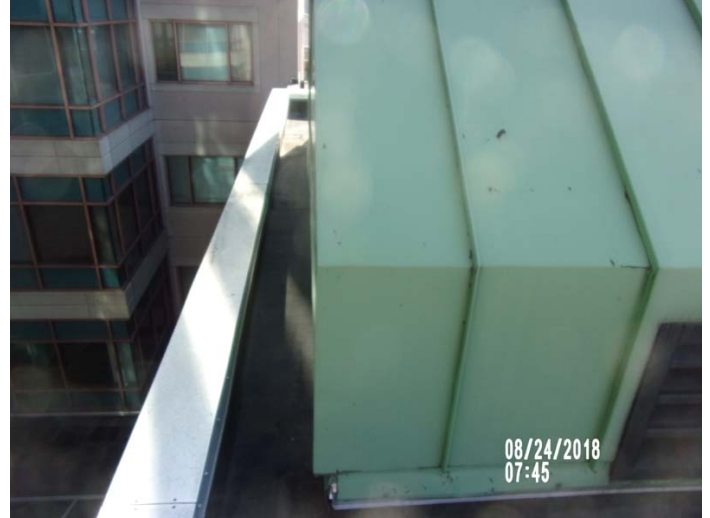
1. Roof Area L1: The majority of this roof area incorporates a standing seam metal roof which appeared to be in good condition, surrounding the metal roof is a flat EPDM roof system.

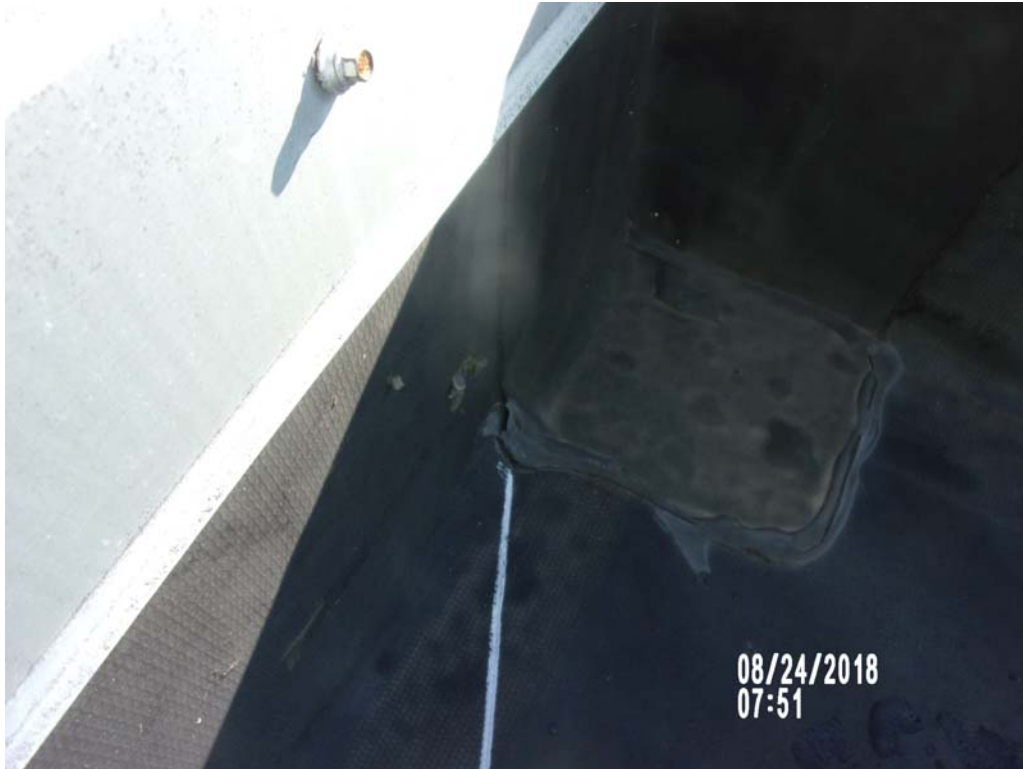
3. Typical opening in corner patch.

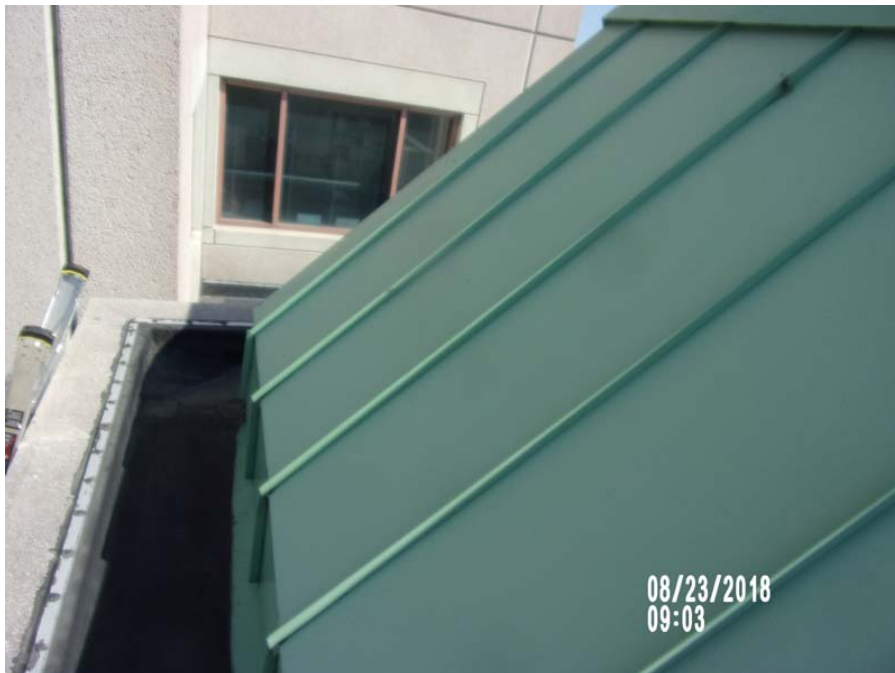
1. Roof Area W: View shows this roof area to be a standing seam metal roof surrounded by a flat EPDM membrane roof system.

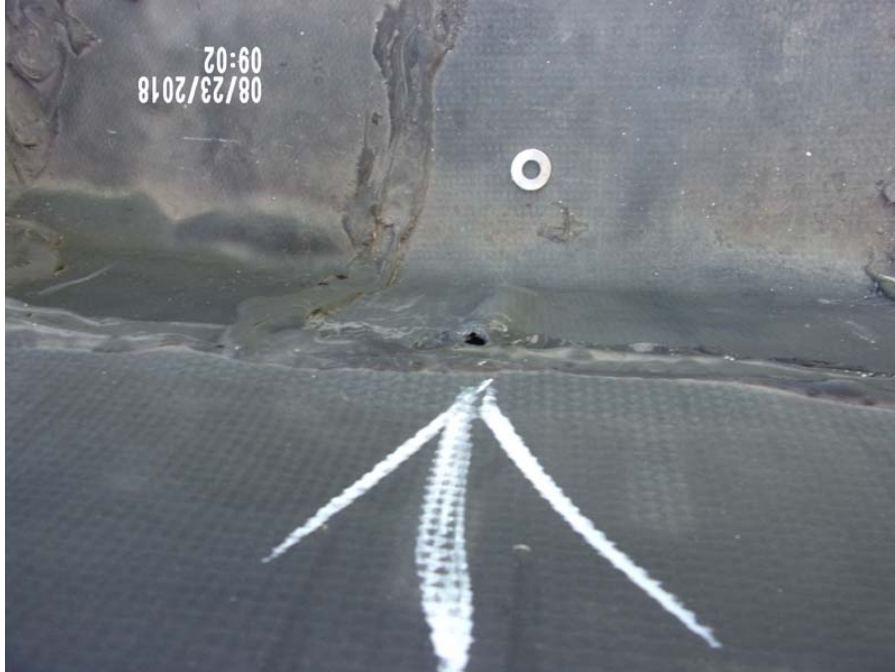
2. Roof Area W: Opening in the EPDM membrane parapet wall flashing.

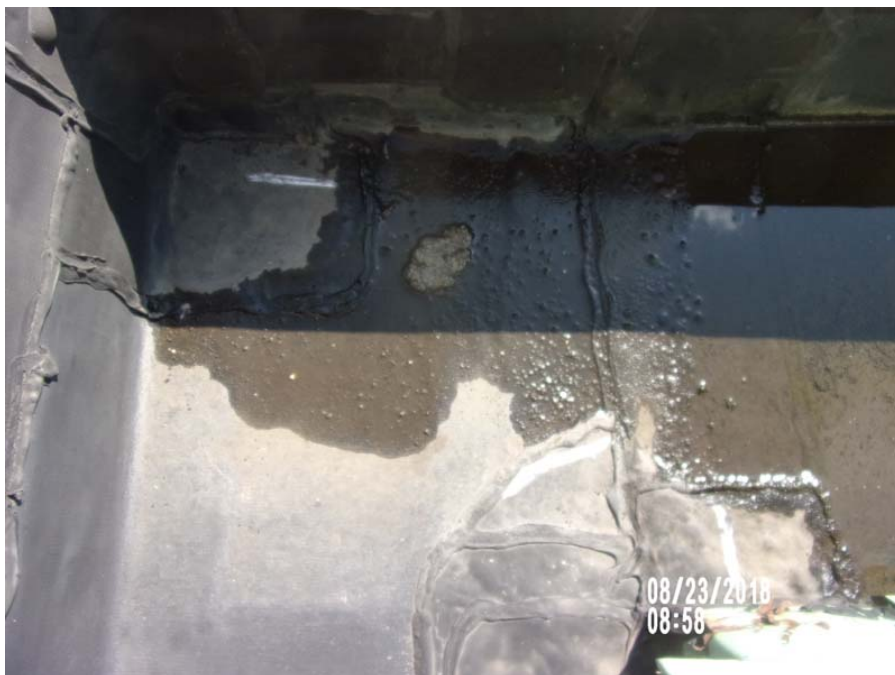
3. Roof Area W: Corner patch delaminating in an area that ponds water.

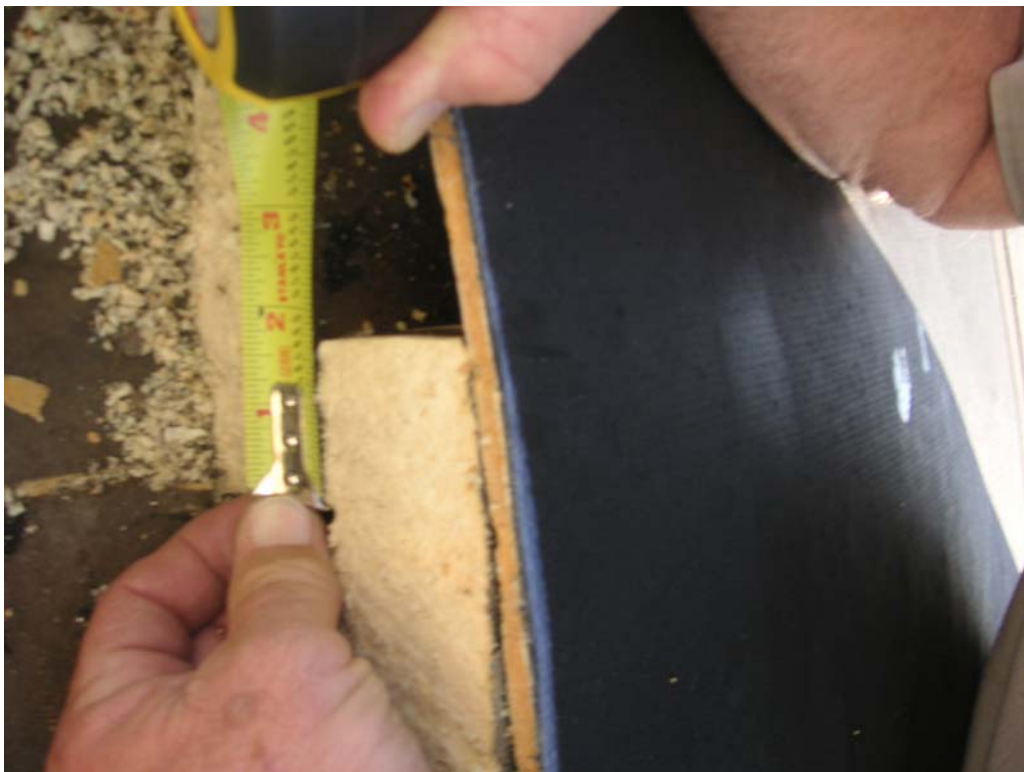
8. 1.5" overlay of board; board is juxtaposed to adjacent board

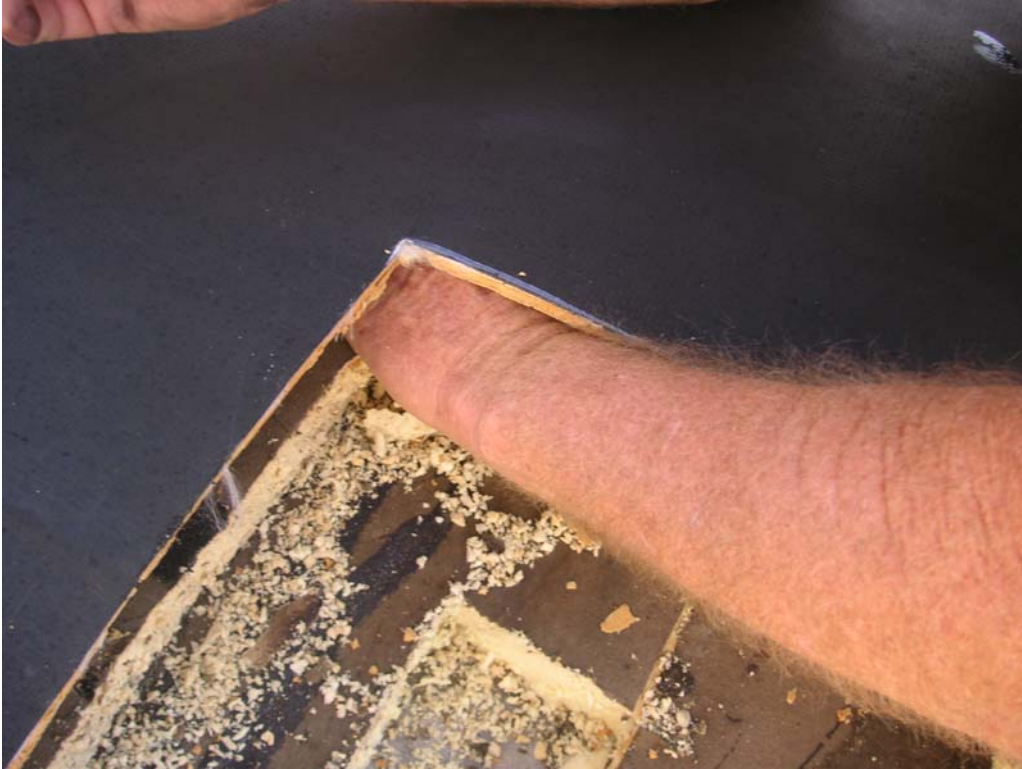
9. Gap under 1/4" hard board

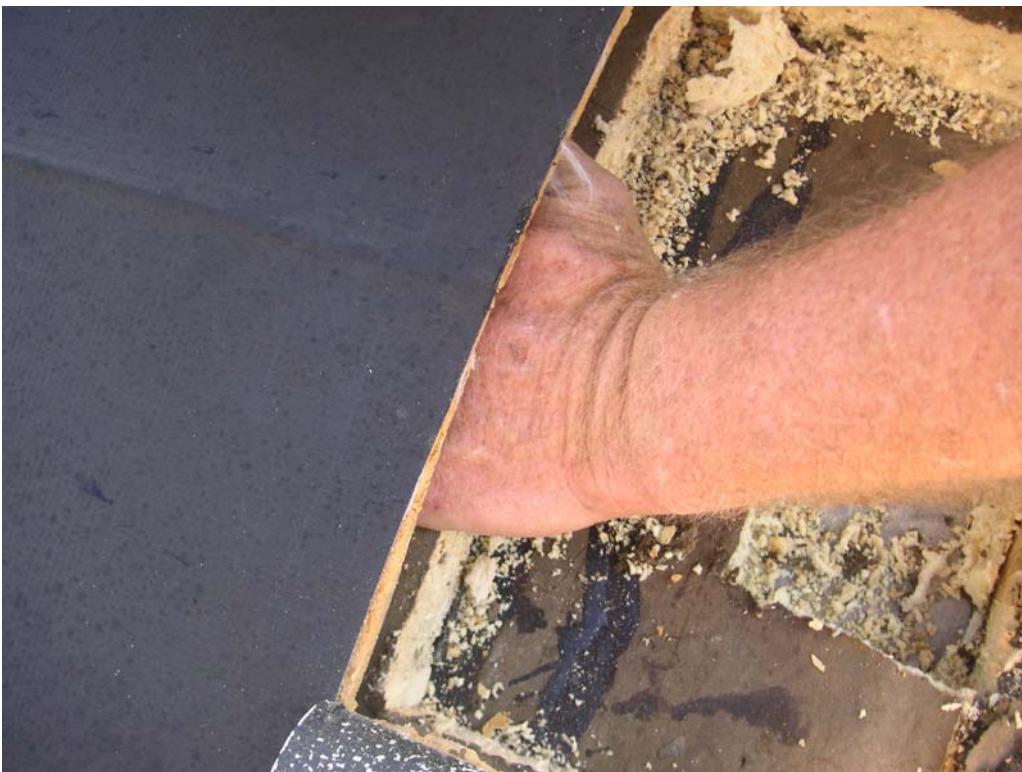
10. 2" gap under hard board

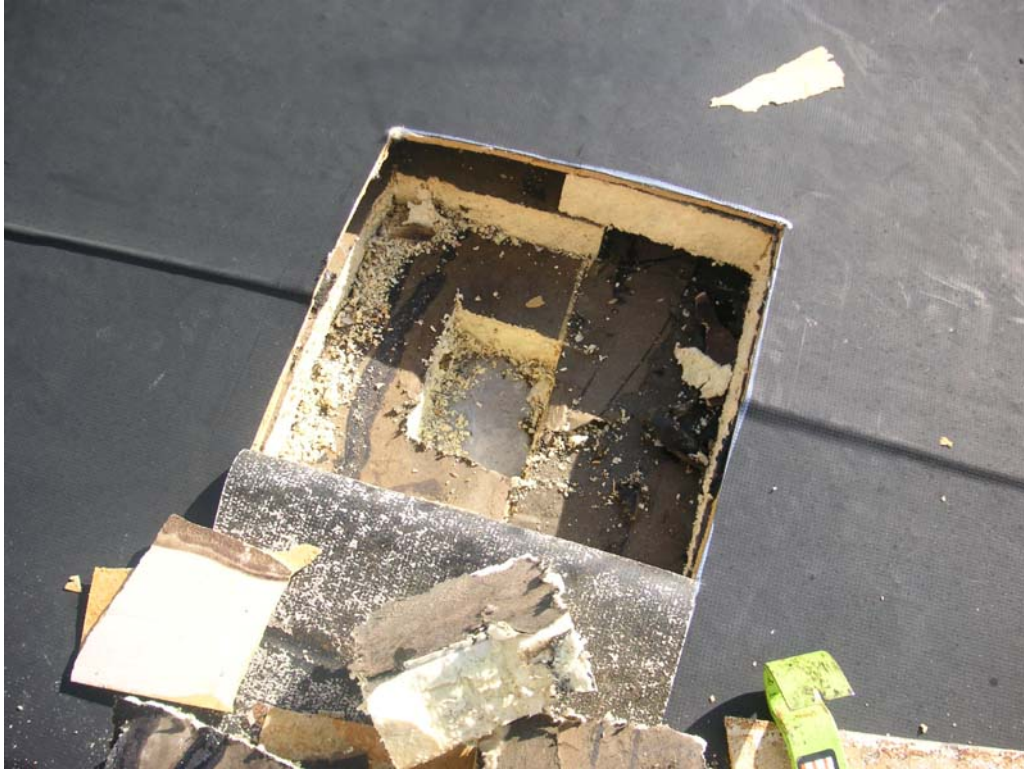
11. Juxtaposed insulation board

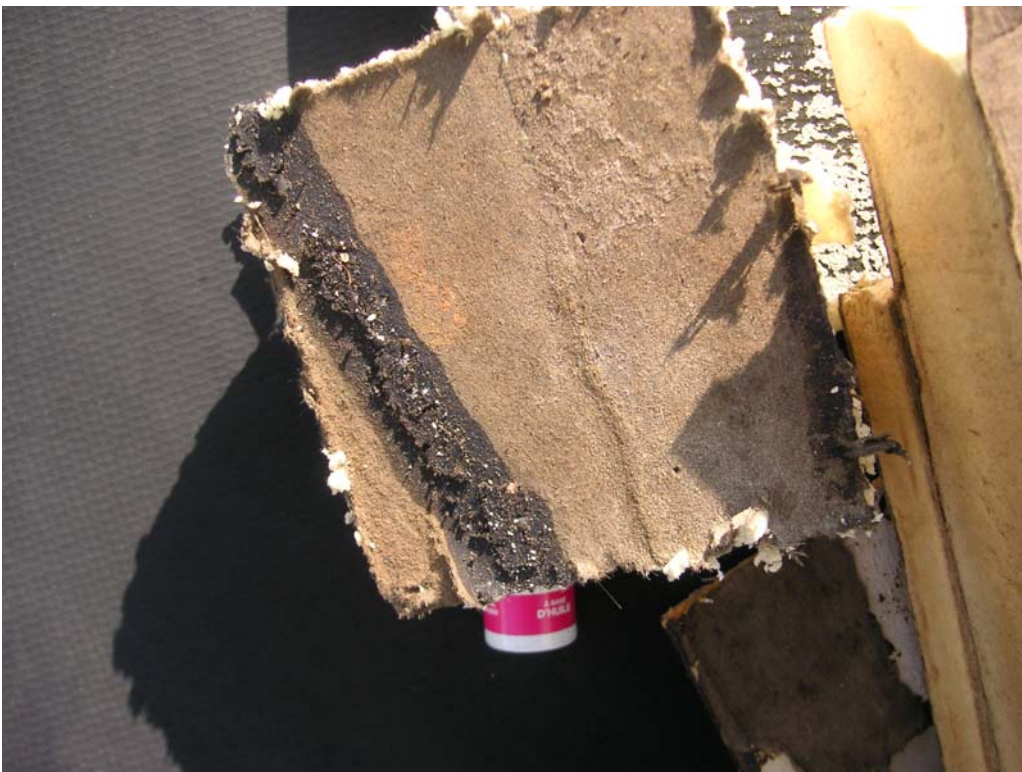
24. Shear of adhesive as movement of thermal stack

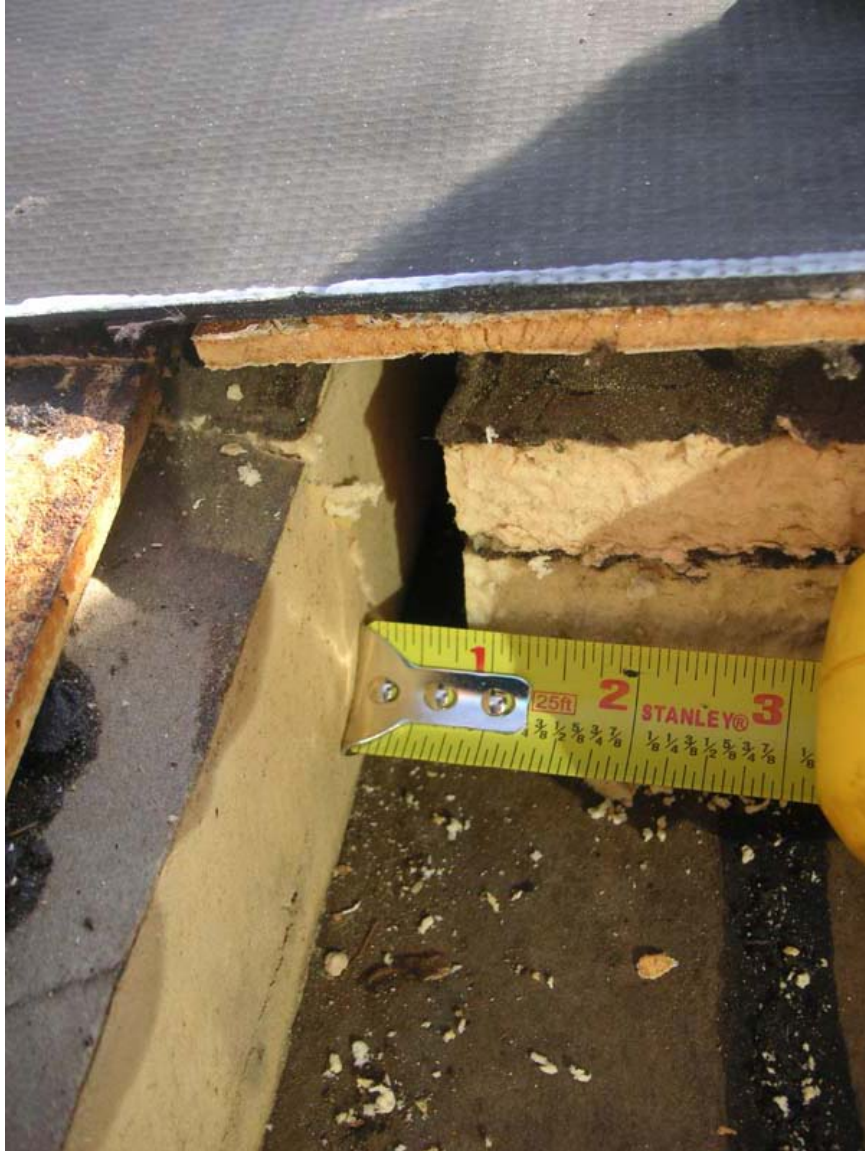
27. Board movement of the thermal stack is $\frac{3}{4}$ " to place the juxtaposed board by $1\frac{1}{2}$ "

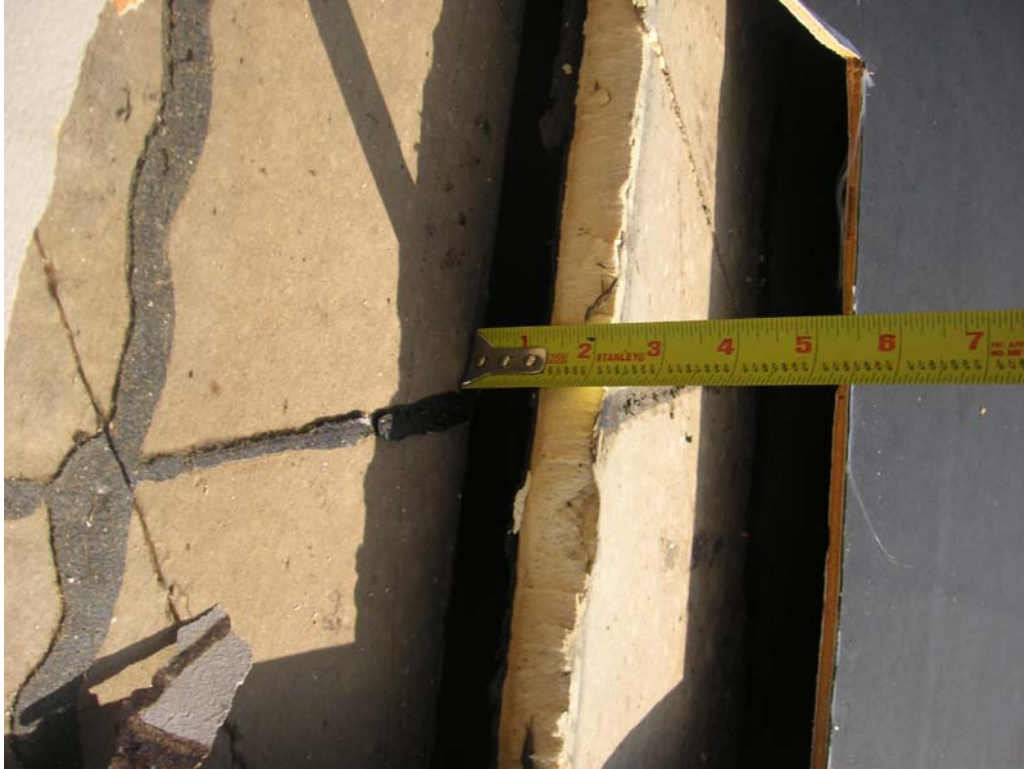
32. Forced gap is 1-1/4"

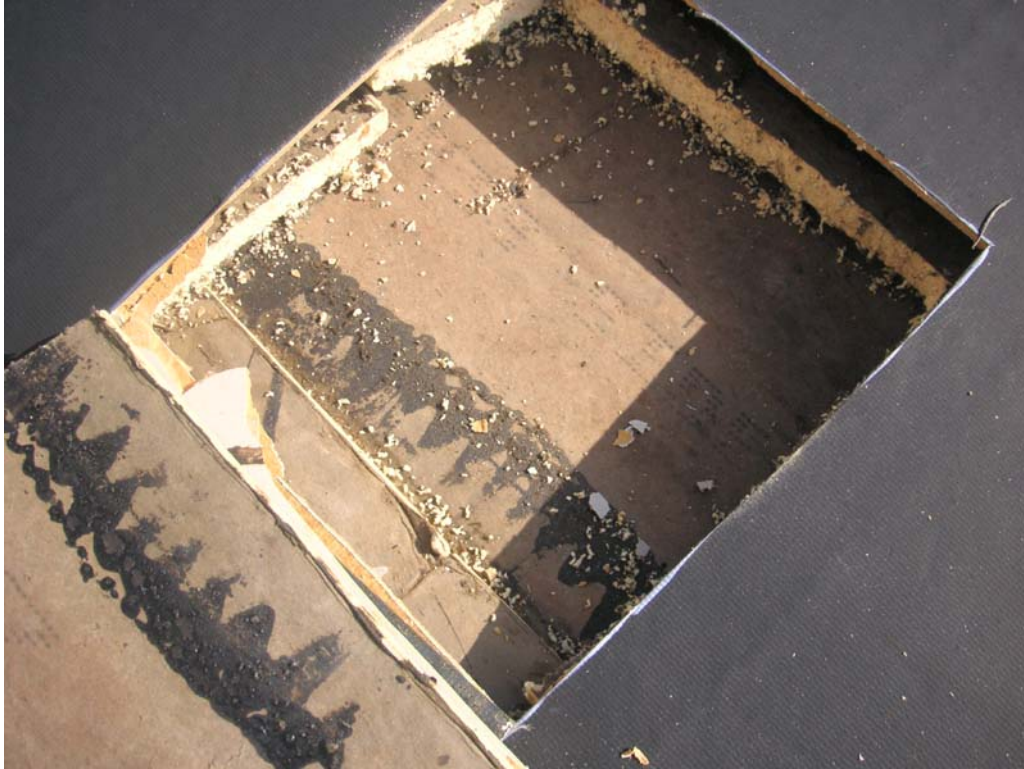
34. Good attachment to base board

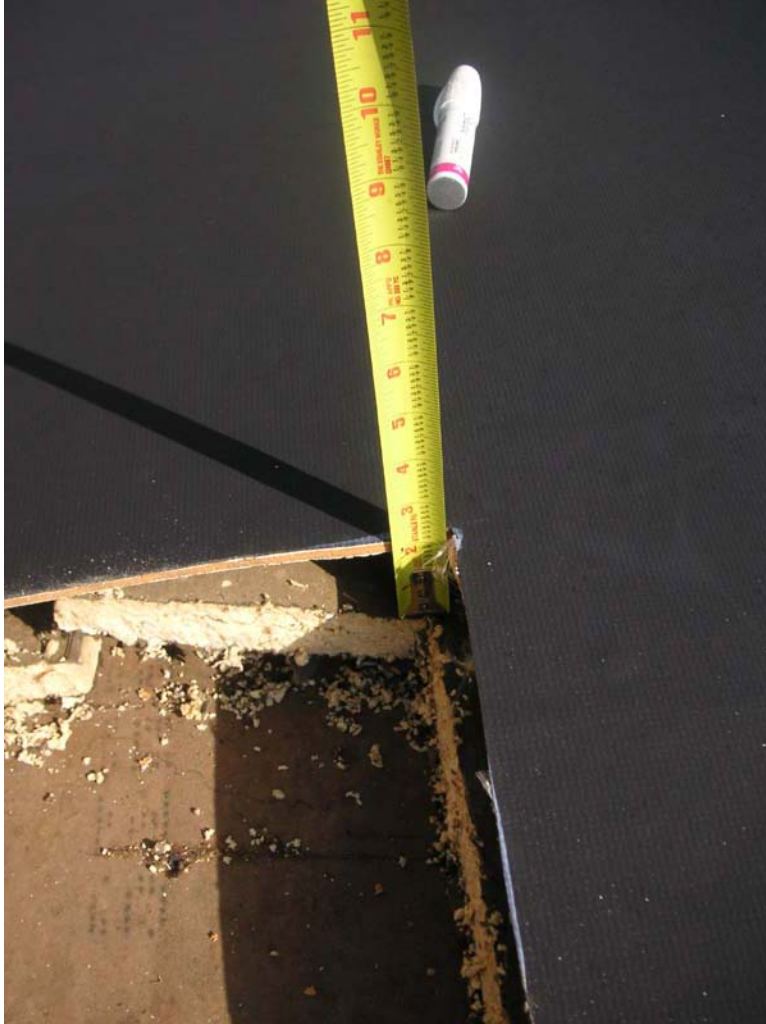
36. 2" gap

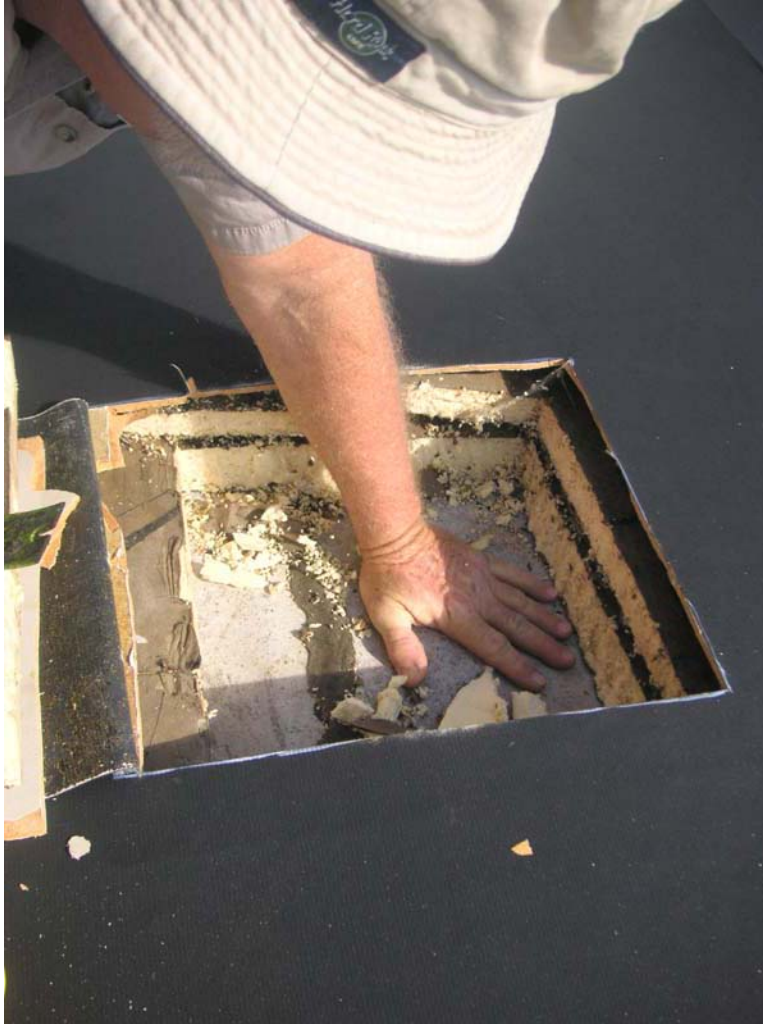
37. Concrete is dry to the touch which is 20% or less

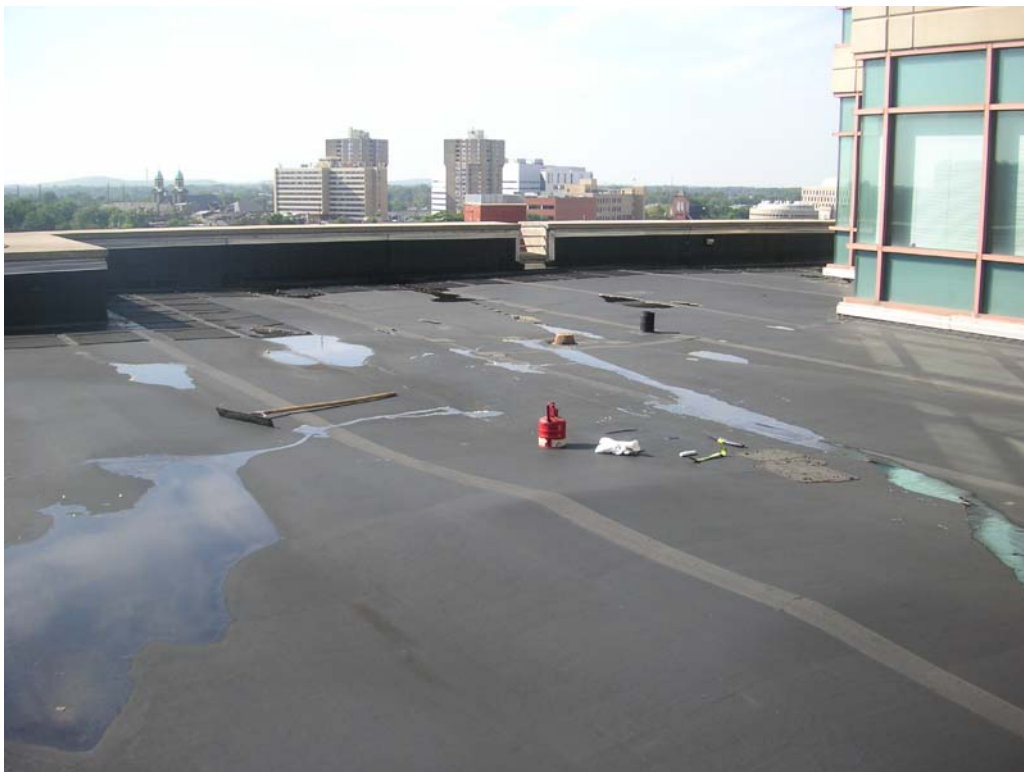
39. Roof overview

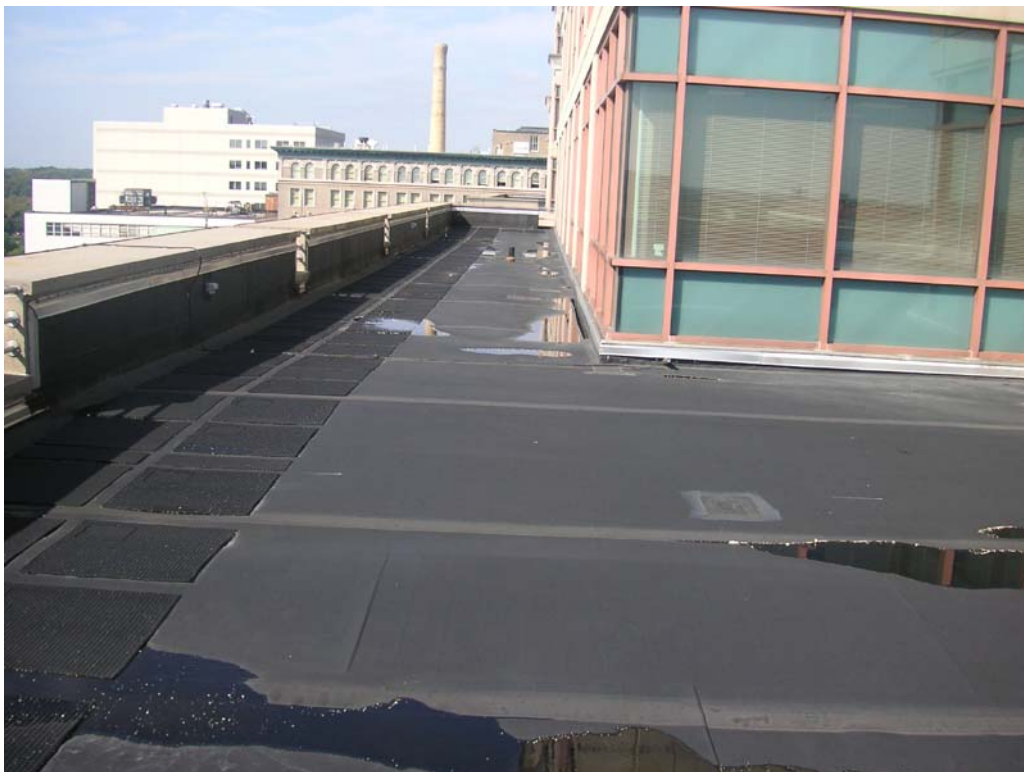
41. View of long leg of the building roof
