SCOPE OF WORK

Trenton Office Complex Roof Restoration

MVC Central Headquarters Building
225 East State Street
Trenton, Mercer, NJ

Project No. A1382-00

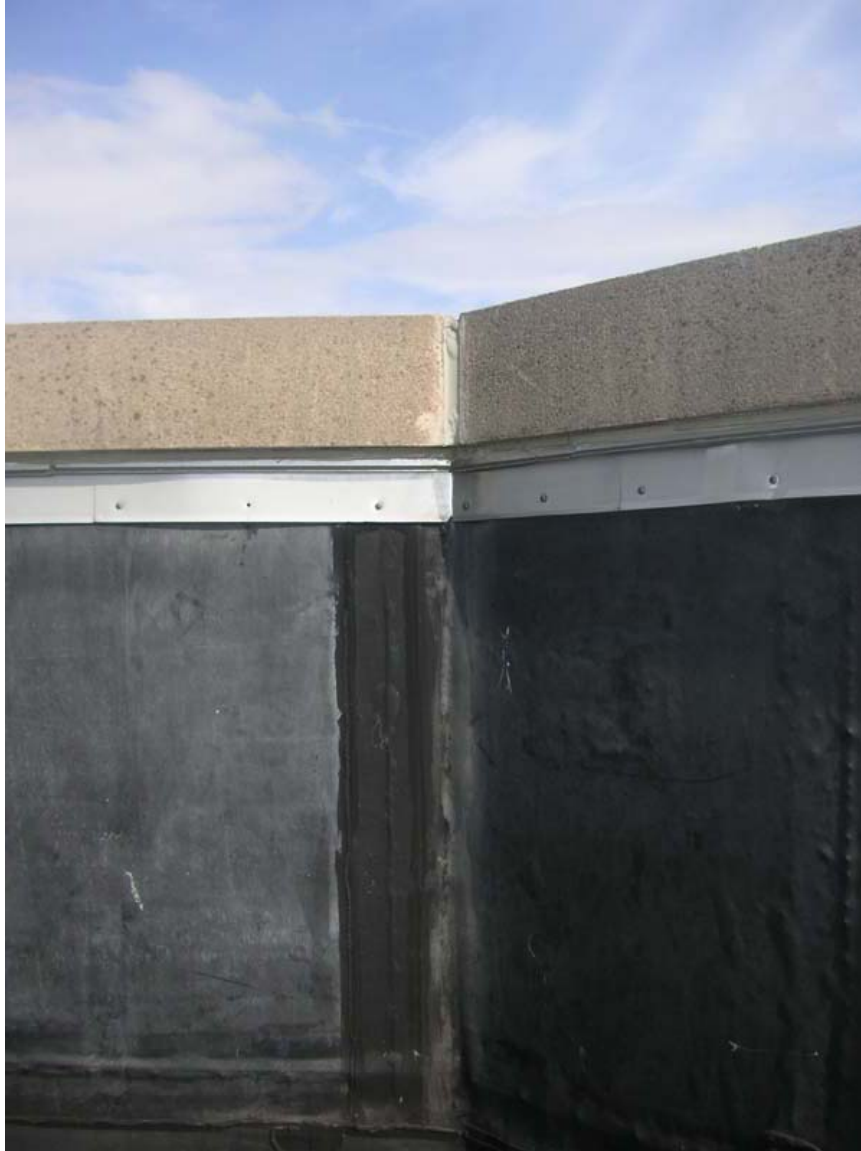
49. Constant drainage point for stone

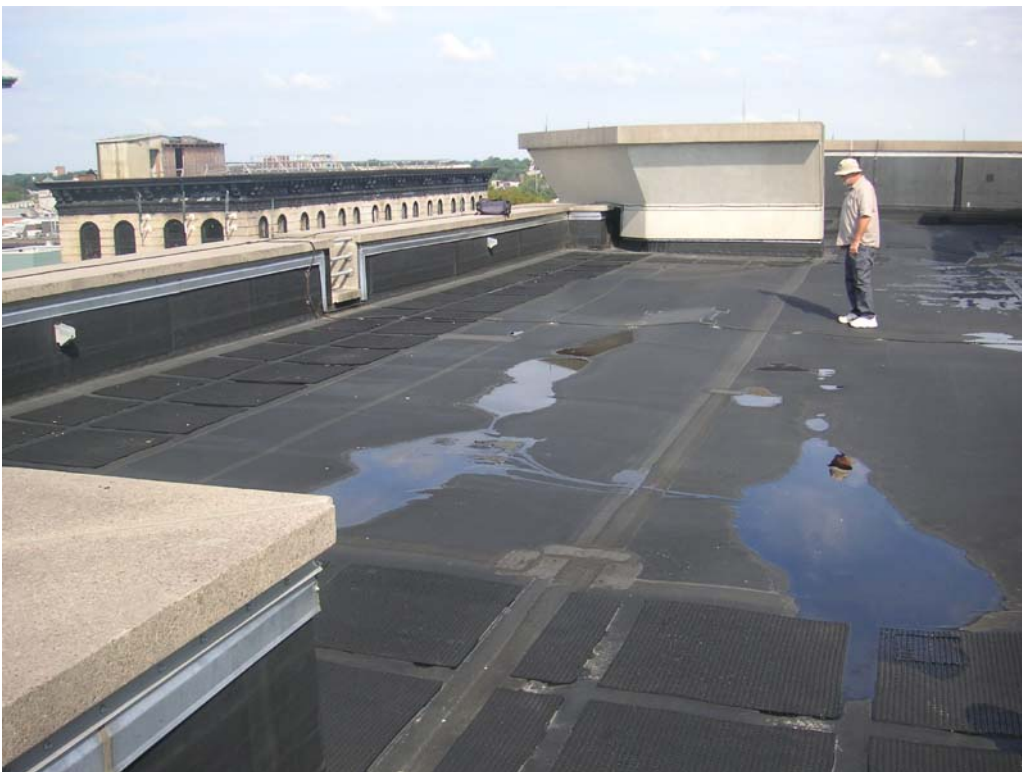
53. Overview

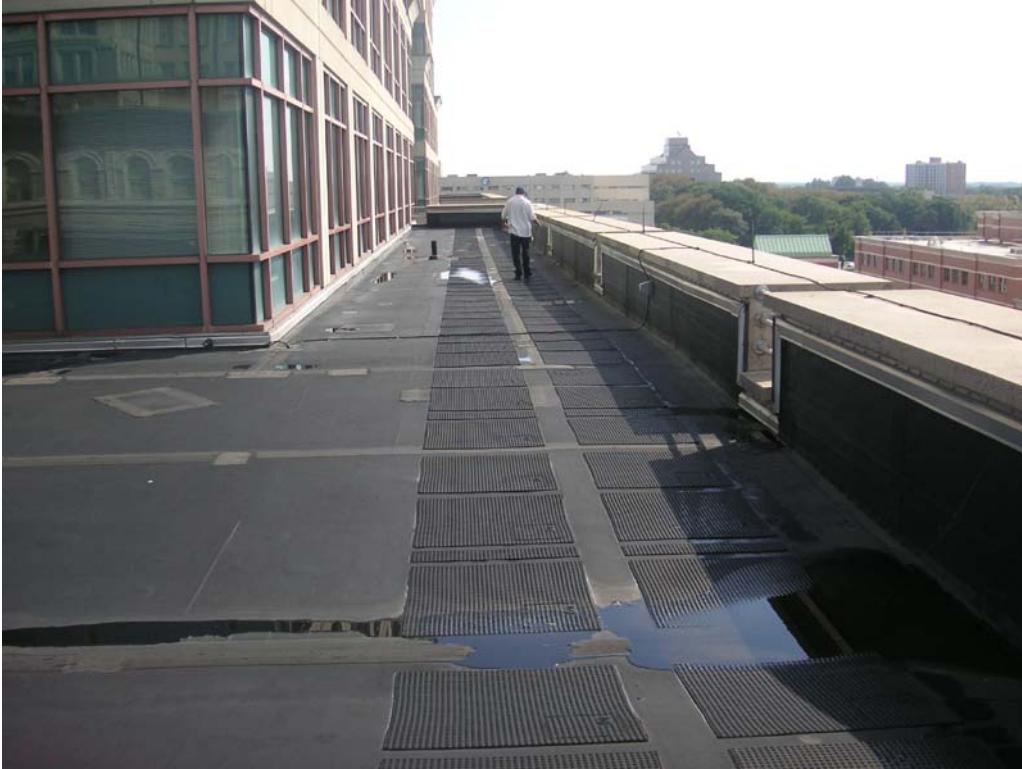
56. Long leg of roof system

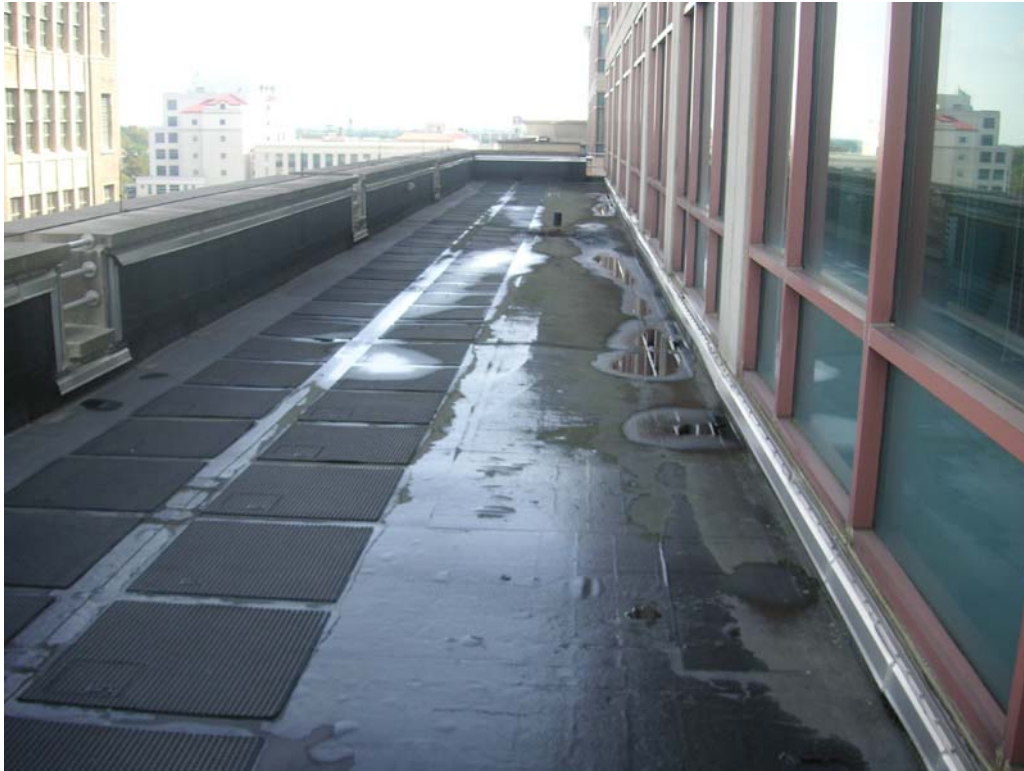
60. North leg of building

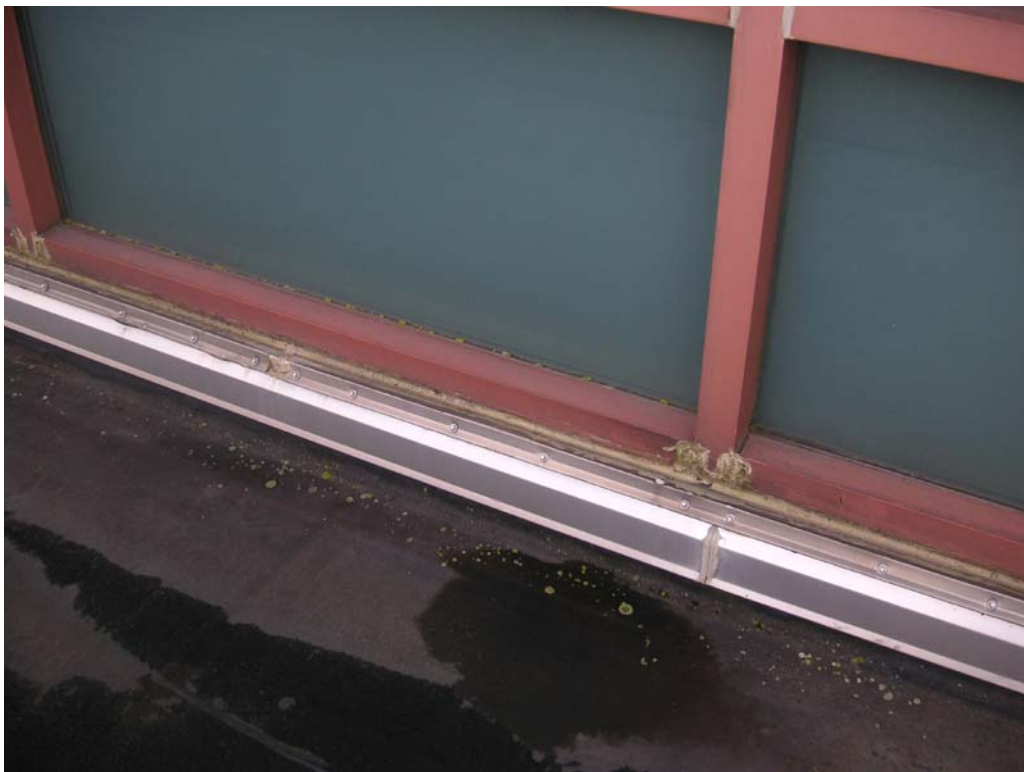
61. Mold

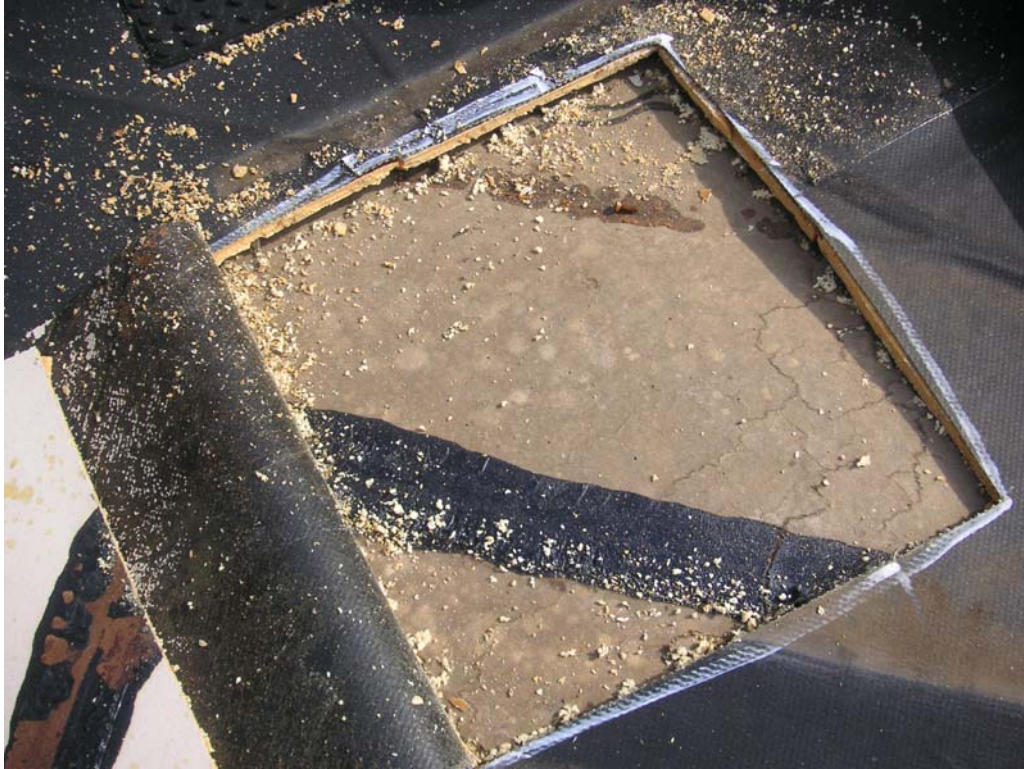
66. Good attachment of hard board; note mold spores

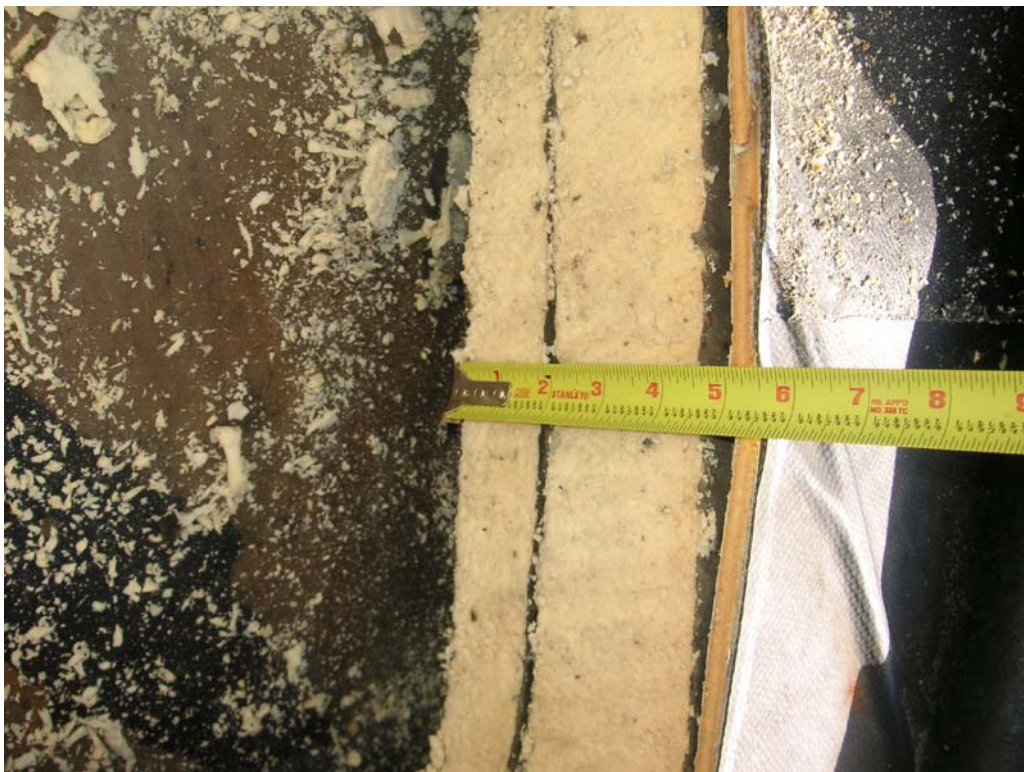
73. 4-1/2" of insulation

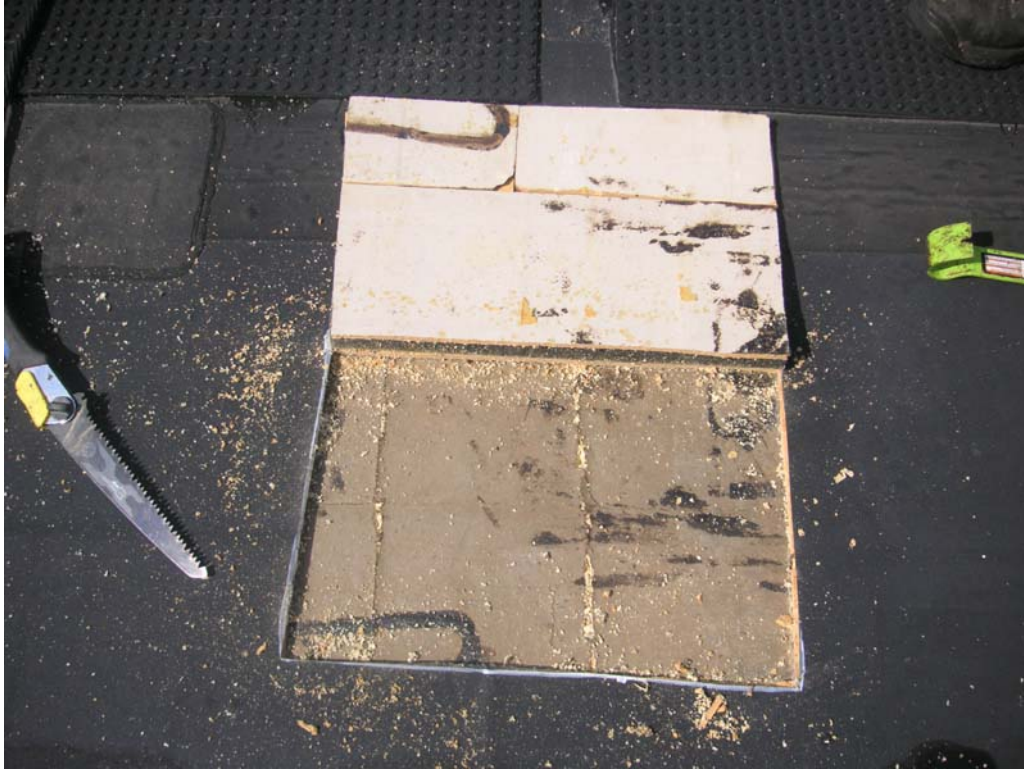
75. Top of hard board

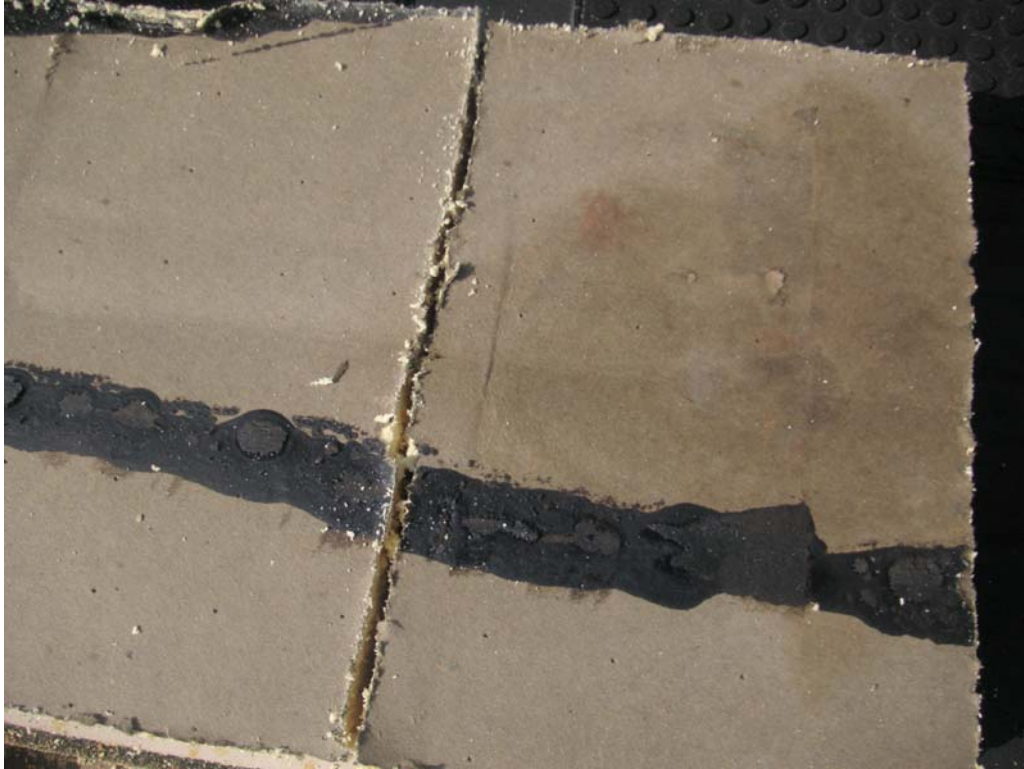
77. Good attachment of top layer insulation

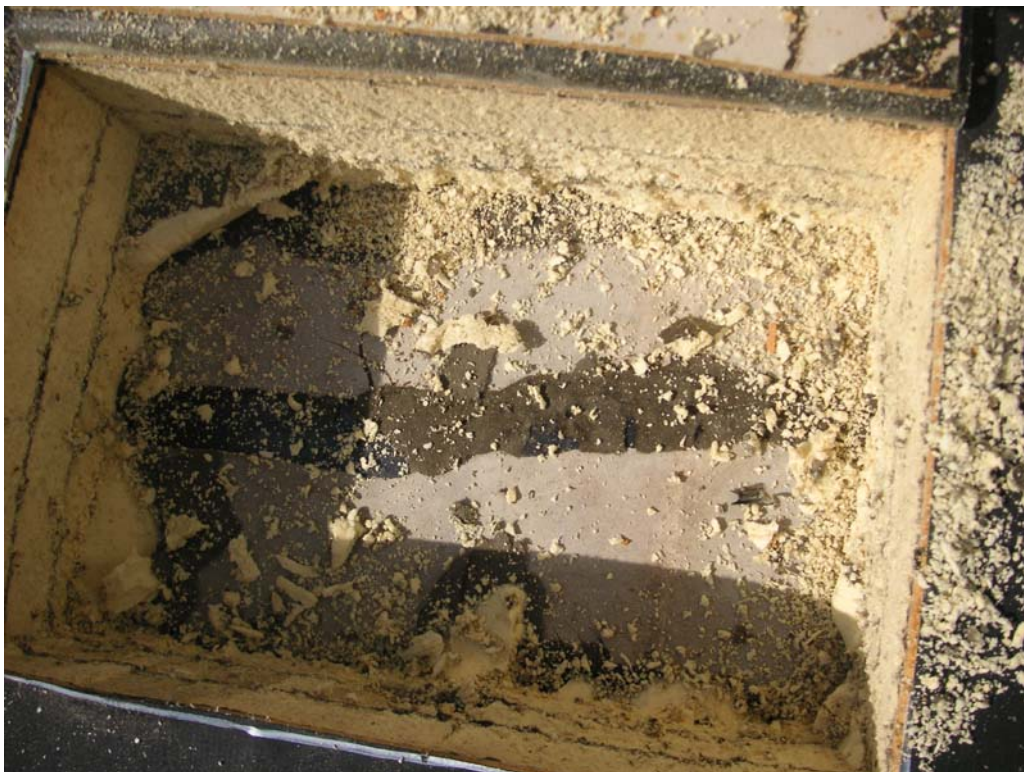
80. Top of bottom layer

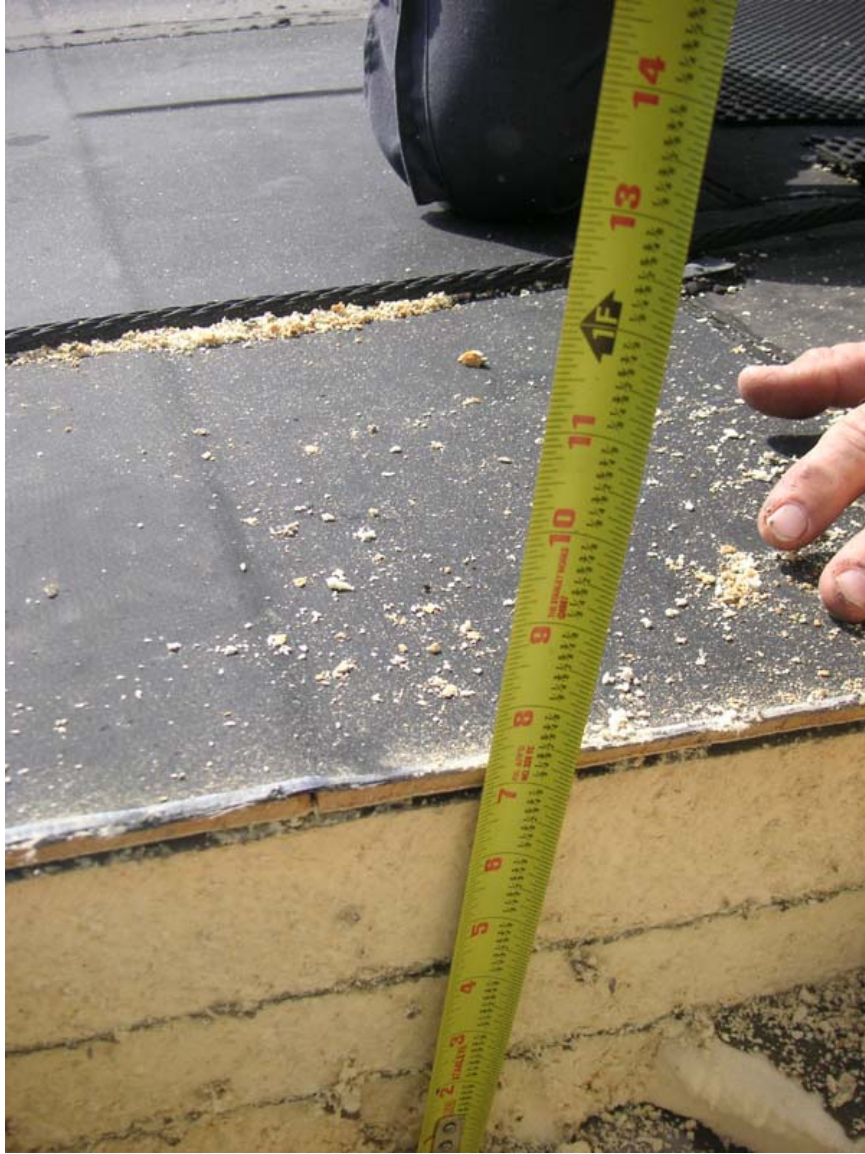
82. Bottom of insulation wetted with bloated facing sheet and mold throughout

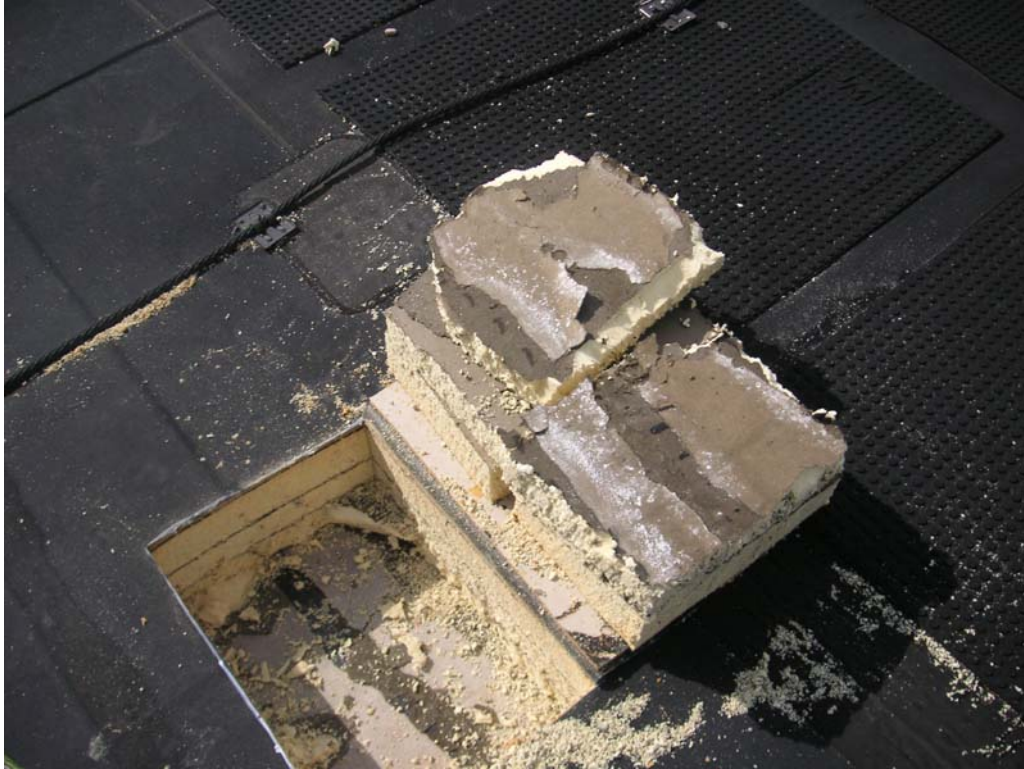
83. Total composite 7"

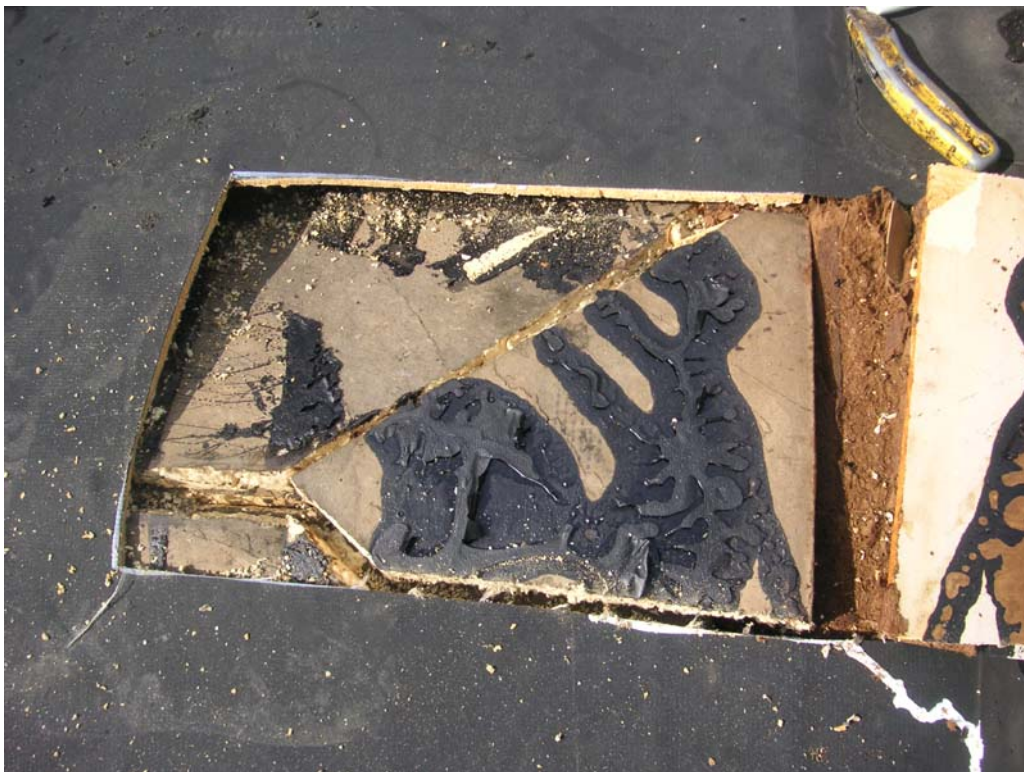
86. Cut adjacent to drain; note saturated fiberboard

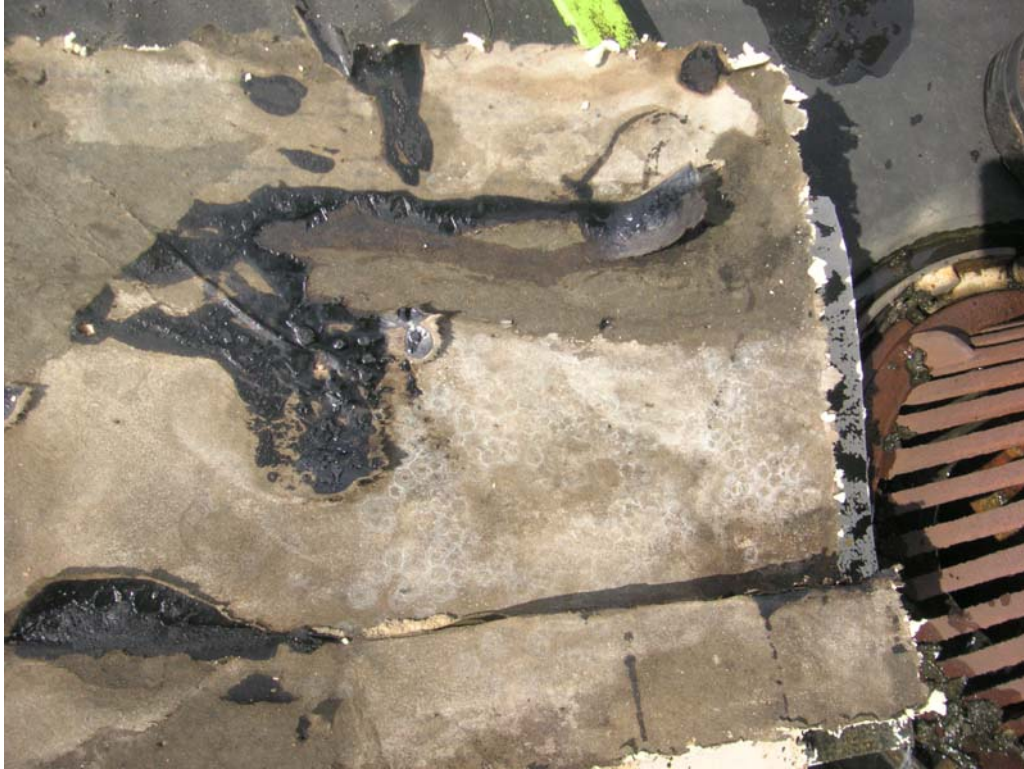
87. Top board with adhesive

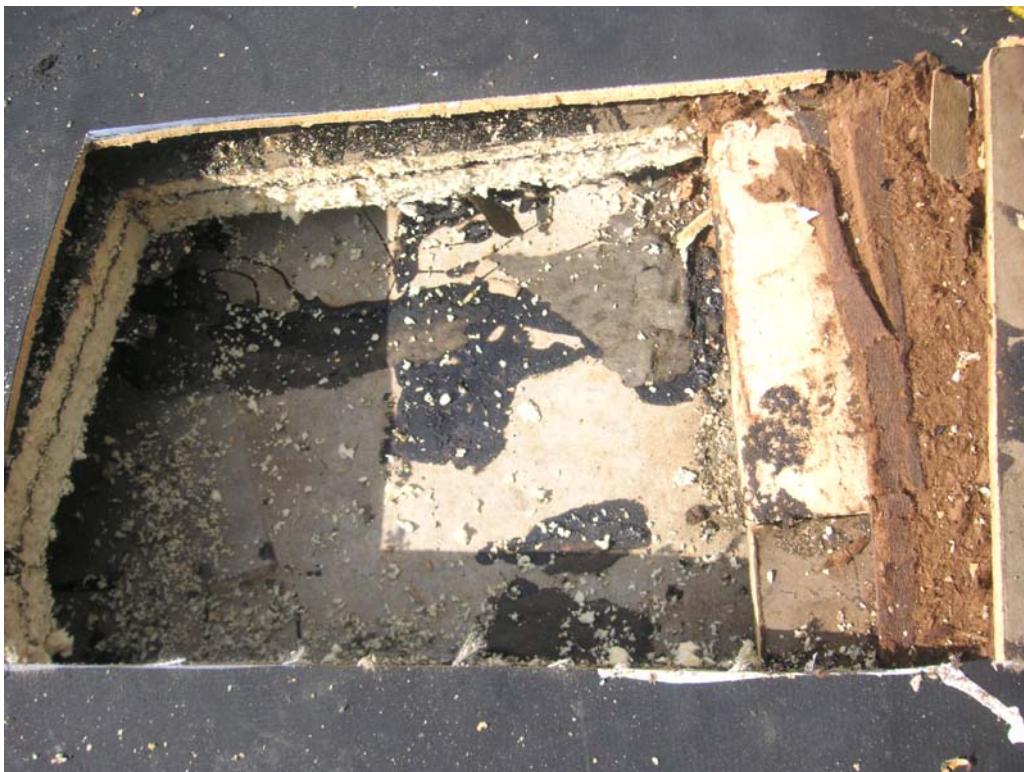
88. Mold spores bottom of 1st board

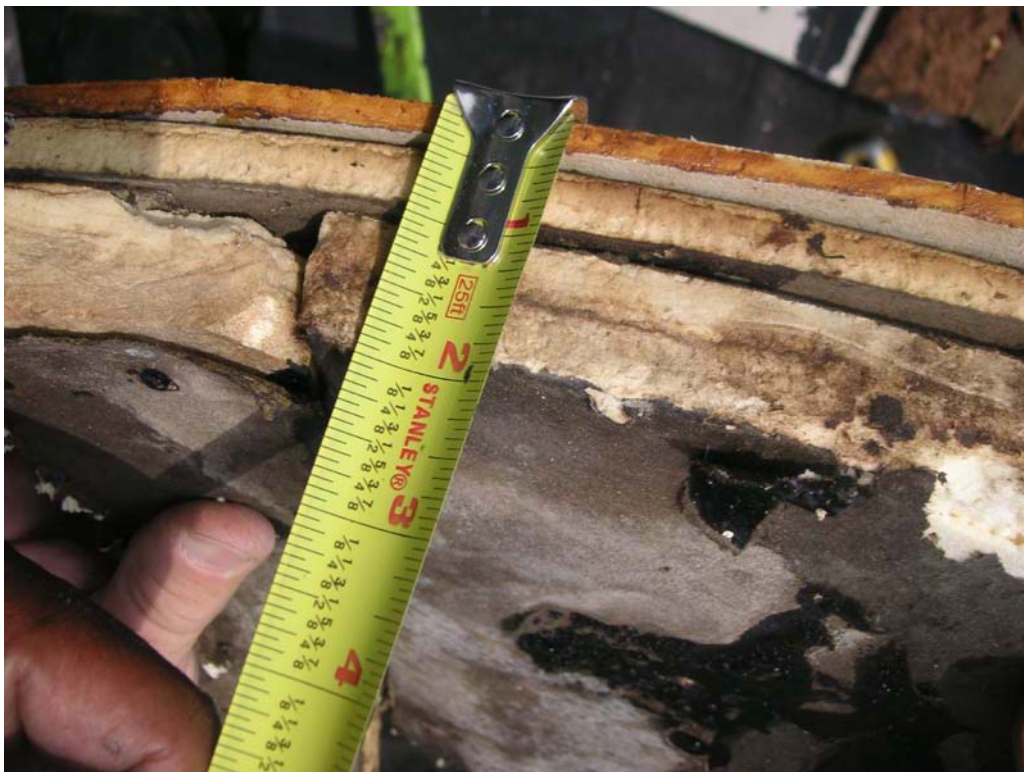
90. 4" heave in insulation

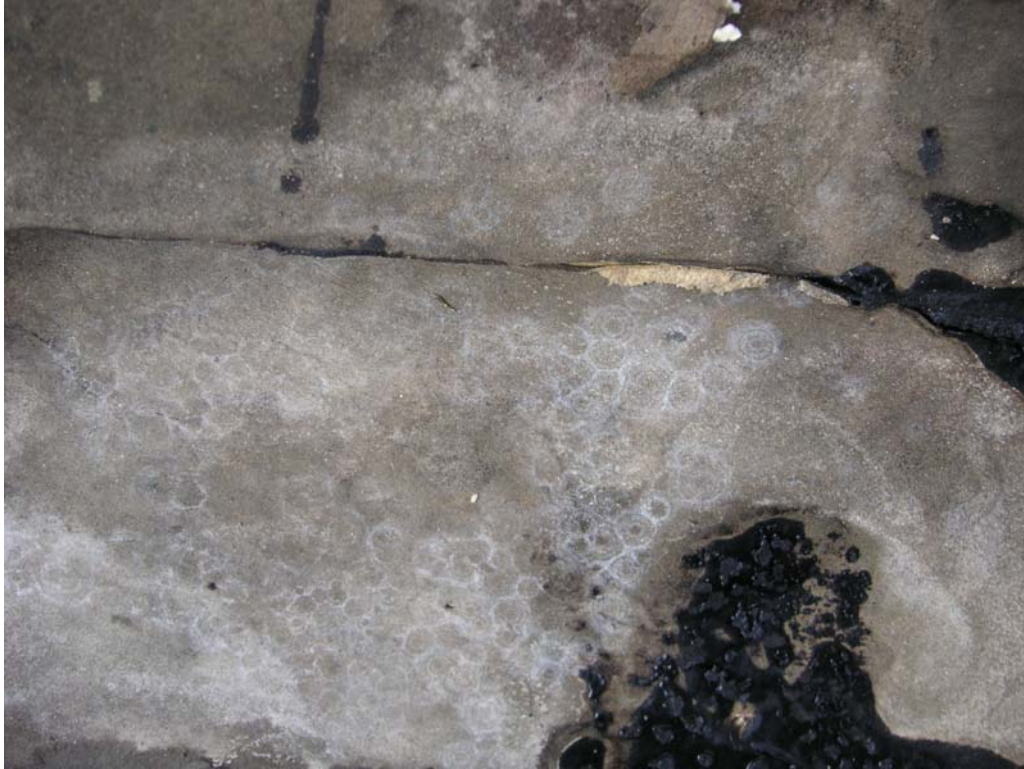
91. Total composite at drain

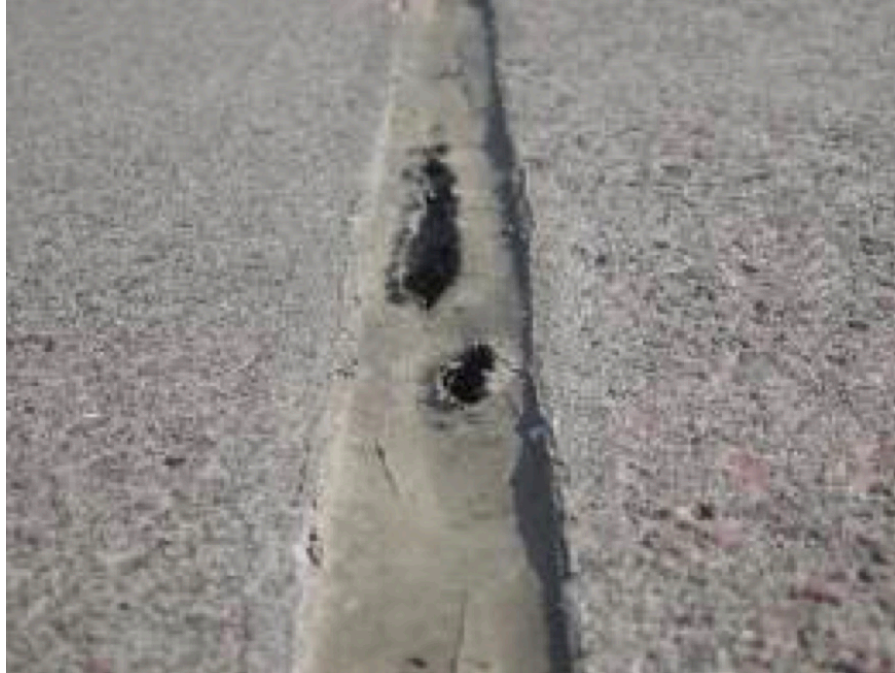
1. Caulking at coping stones.
Voids in the caulk joint. Not enough caulk was placed into the joint to cover the neoprene roving.
Caulking by spec is 1/2 of joint width.

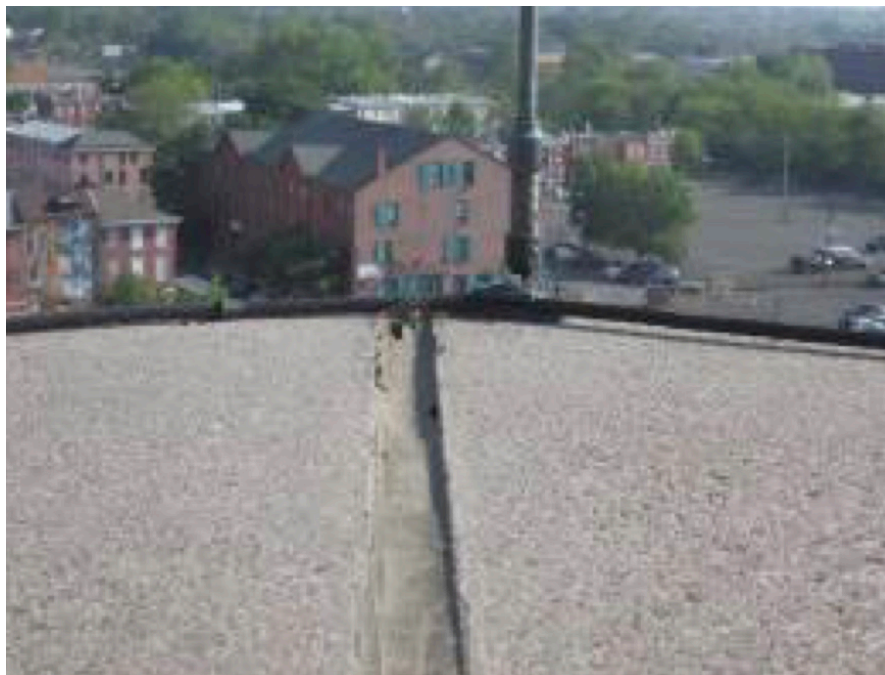
2. Caulking at coping stones.
Split at end of caulk joint on exterior of building.

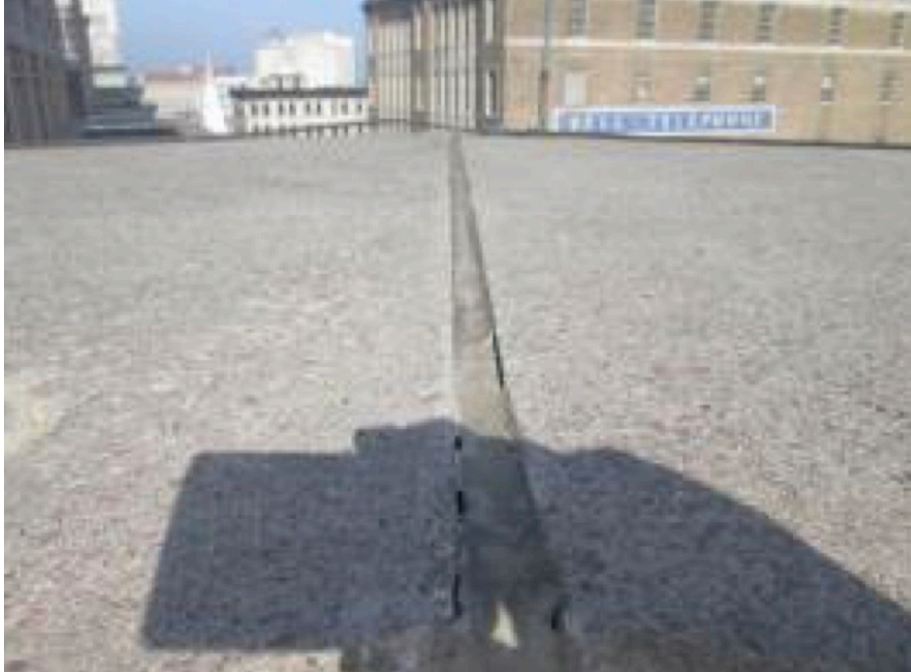
3. Caulking at coping stones.
Multiple openings in joint allowing water into system.

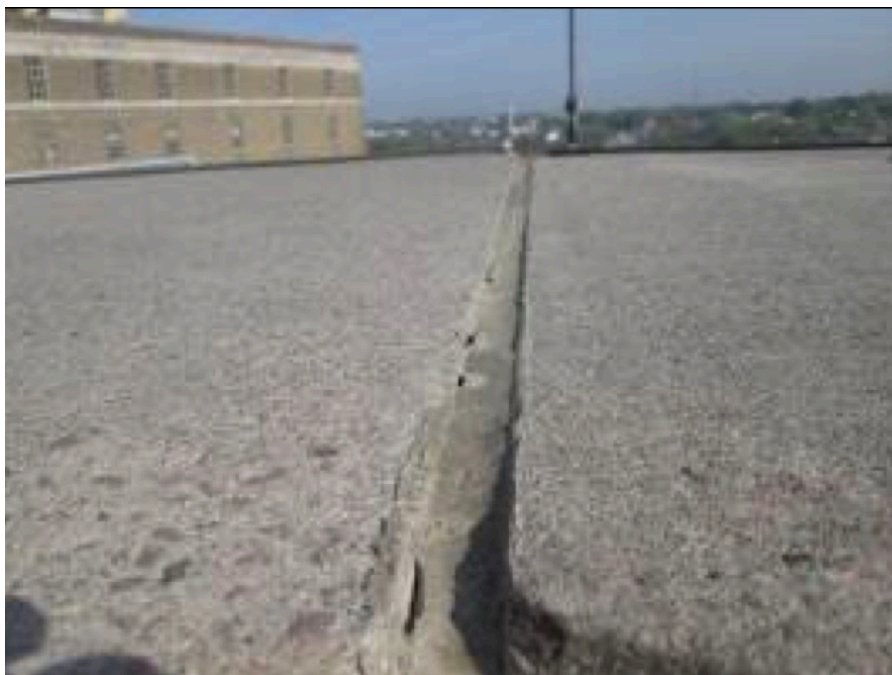
6. Coping
Cast stone is 44" wide. Gaps and blistering in joint allows water to migrate on top of the roving and into the block wall of the concrete deck.

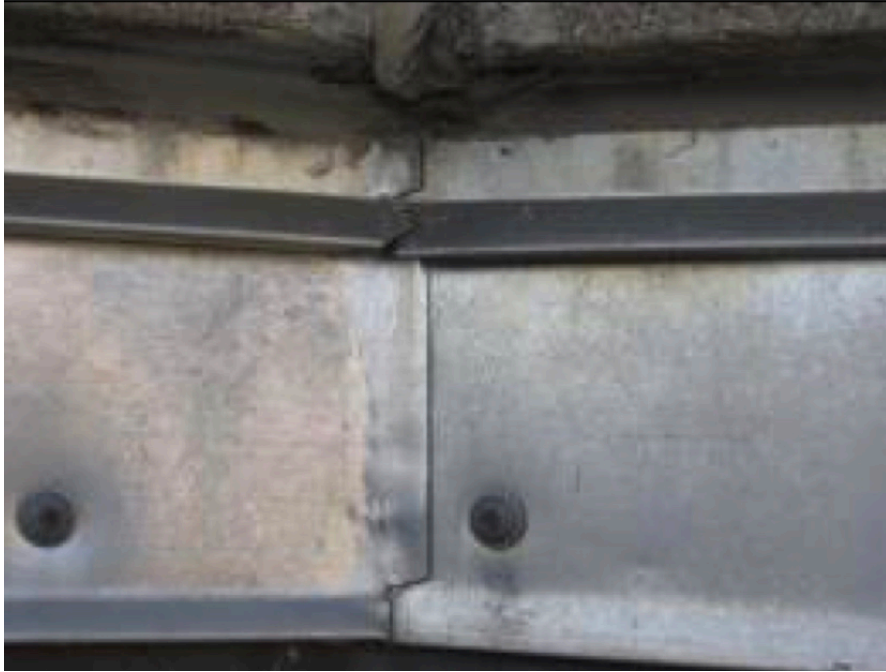
11. Caulking at Windows.
Limited overlap in metal to prevent water migration into system

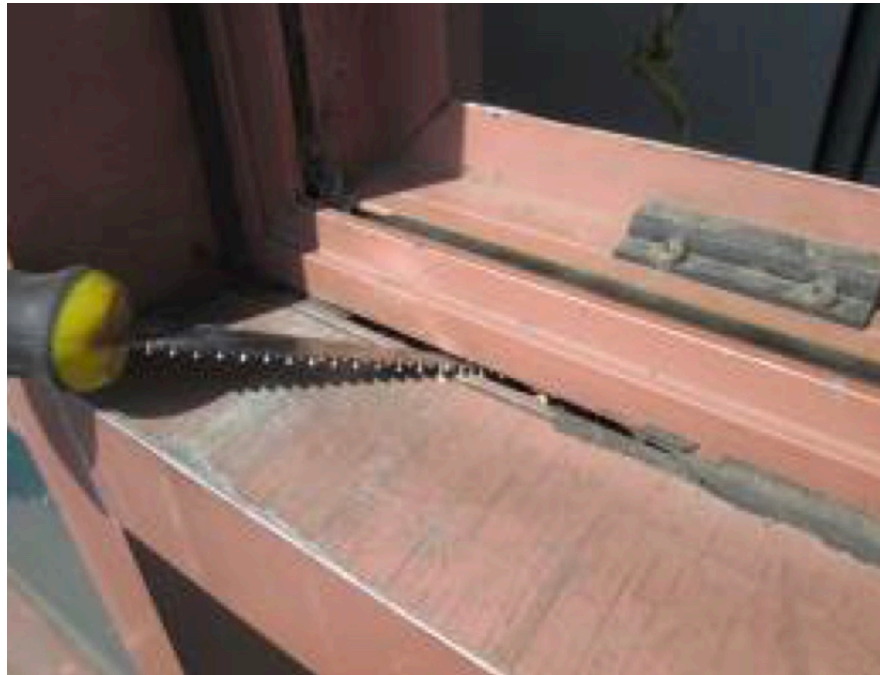
12. Caulking at Windows.
No backer rod behind metal sill plate of window
